2CV HARD LUCK STORIES

Revision 4

By Graeme Dennes

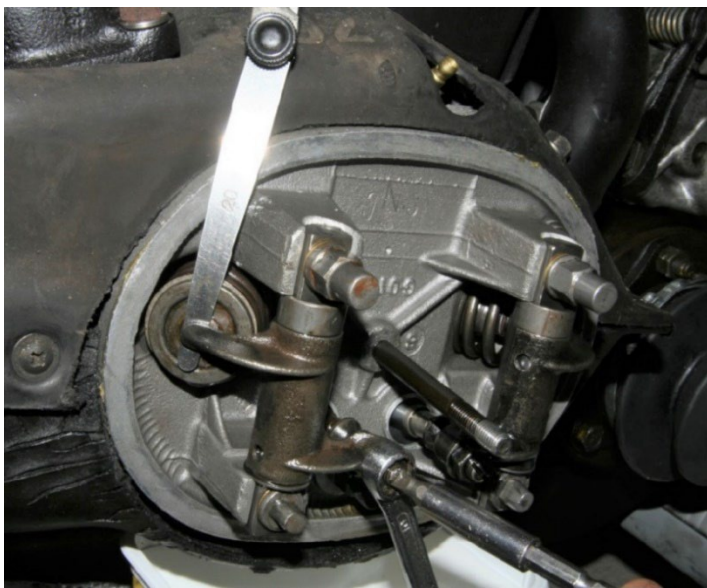
There was another item which hadn't been checked. Valve clearances. See photo at left. After the engine had fully cooled down, the rocker covers were removed. The head bolts seemed tight but were not further tightened (no torque wrench at hand). The valve clearances were checked, and this is what was found: the two inlet valves were exactly correct at 0.2mm, but both exhaust valves had not only presented with *zero* clearance, but were in fact being held open by some small amount, meaning they were never able to fully close. Definitely not good!

Further, the exhaust valves were receiving no cooling as they never came into contact with the valve seats. This would have resulted in the exhaust valves running at very high temperatures and potentially being destroyed. Definitely not good!

On analysis, I expect the large out of balance forces (the engine was pounding the engine mounts after it fired and until it reached idling speed) was because only one cylinder was firing during start up and idle because the other cylinder couldn't raise the necessary compression pressure required to ignite the fuel mixture because its exhaust valve was being held open for too long. However, it still managed to start on one cylinder which already had a held-open exhaust valve! How the car even started leaves me astounded. Above idling speed and up to driving speed, the (slightly) held-open exhaust valves would have had less effect on engine power, as by then, both cylinders would be firing and providing their part of the total engine power with plenty of air-fuel mixture being drawn in at the higher engine RPMs, so the small amount of mixture escaping during the compression and expansion strokes via the open exhaust valves, along with the reduced compression pressures, may not be easily noticed. If only one cylinder was operating at idle, it would help to explain why adjustment of the idle mixture screw had such little effect.

With the exhaust valves held open in this manner, the basic engine timing diagram (crankshaft angle vs valve open/close positions) was quite displaced from the correct settings. This, coupled with only one cylinder operating at idle, could well have caused the weird engine/manifold/exhaust note. It also means that instead of all the fuel-rich air mixture previously drawn in on the inlet stroke remaining in the cylinder to be compressed on the compression stroke, some of it was escaping (being pushed out) via the held-open exhaust valve and pushed into the exhaust manifold and cross box where it was later ignited in an explosive manner by the next burst of hot burnt gasses discharged on the following exhaust stroke. This too would have changed the engine sound.

It seems very odd that the inlet valve clearances were on specification but the exhaust valve clearances had not only closed up to zero so the rocker arms were always in contact with the valve stems, but the adjustment screws had been positioned even further inwards (clockwise) to where the valves were no longer able to close. The adjusting lock nuts appeared to be tight!

Could it have been due to the locknuts not being adequately tightened, allowing/causing the rocker adjustment screws to rotate in a clockwise direction under the influence of the net mechanical forces at work, driving the valves further out of the heads. Perhaps it was only because the locknuts had tightened up that prevented the valves being pushed even further into the combustion space, and into the domain of the piston!! I'm at a loss to explain how this situation could arise if the exhaust valves had been set correctly last time they were adjusted.

After setting the exhaust valve clearances to 0.2mm, the rocker covers and nuts were refitted hand tight, then a further one and one-half turns with the spanner. The idle mixture screw was set to three and one half turns outwards (counter-clockwise) from being (gently!) seated. The engine started immediately, and the strange engine sound had gone. After checking there were no oil leaks from the rocker cover gaskets, the idle speed was adjusted to 825 RPM in conjunction with adjustment of the idle mixture screw. The oil was topped up. All seemed fine as far as could be determined.

In summary, at each annual service, set the valve clearances. It only takes a few minutes. Refer to the writer's article, *2CV Valve Clearance Adjustment* for the complete procedure.

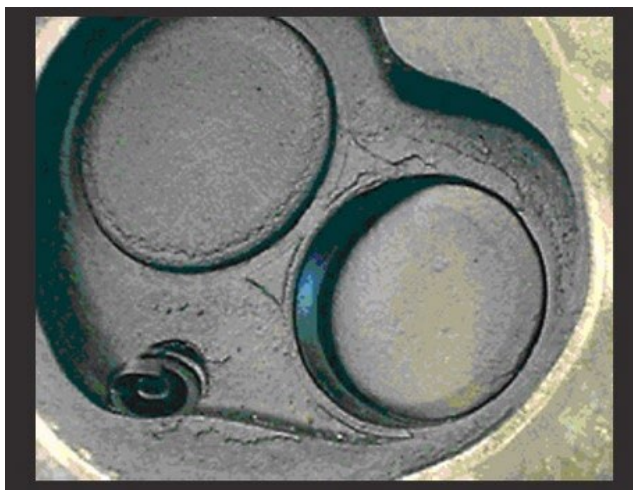
This implies hardened exhaust valve seats were used in 602cc engines. If this is the case, then it's most unlikely to be exhaust valve recession, but it still could be. The engine heads will require removal and inspection. The valve at the lower right in the photo on the left (not a 2CV) has a bad case of valve recession. The valve seat has worn away quite severely, allowing the valve to sit quite deeply into the head. A head repair *will* be needed to fit at least one new valve seat and one new valve.
