2CV HARD LUCK STORIES

Revision 5

Graeme Dennes

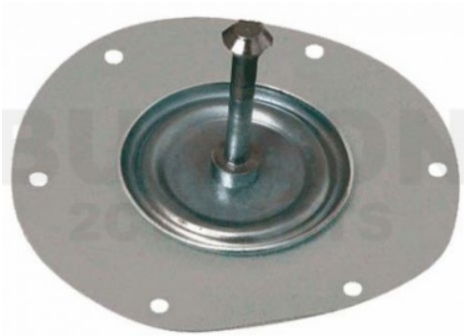
Away From Home Problem 1:

While away from home, our orange 2CV would run for perhaps 2-3 km, then almost die from what seemed like fuel starvation, but, with much encouragement it would (blorp, blorp, blorp, just) come good again, and after a couple of kangaroo hops, off we'd go again (blorp, blorping blorping), with the process being repeated. Fuel was not overflowing from the carburettor, which would otherwise indicate a failed float valve. It seemed probable that it was being caused by either dirty fuel (possible), a restriction in the fuel line from rubbish from the tank (less likely), a dirty fuel filter (possible, but the filter had just been changed), a sticking carburettor float valve (repeated cycling with a sticking action is very unlikely), dirt in or around the carburettor jets (possible), or a fuel pump failure (possible). It could also have been due to rubbish trapped in the fuel filter, whereby the very act of fuel being drawn through the fuel filter by the pump pulls on the rubbish sufficiently to cause the filter to block itself off, when the engine would stop or almost stop, at which point the rubbish would fall away again, allowing fuel to pass, and repeating the cycle. However, as the fuel filter had just been replaced as noted, I discounted that option for the moment. I therefore put my money on the fuel pump diaphragm, so my first step was to disconnect the rubber fuel hose from the carburettor fuel inlet spigot, then start the engine for just a few seconds to check how much fuel was being discharged from the fuel hose. Ah ha, gotcha! It was found to be almost zero. As no spare fuel pump or diaphragm was carried as a spare, RACV Total Care gave us a lift home!

I later confirmed that the fuel pump diaphragm had suffered a small tear, causing the problem. The diaphragm material had also become sufficiently "floppy" such that very little pumping action was occurring anyway.

And what have we learnt? As the fuel pump diaphragm is not generally inspected, my new rule is to change it every five years, reminding myself by an entry in the maintenance log book. If unsure when the diaphragm was last replaced in your car, do it now as a matter of urgency. Always carry a new spare diaphragm or pump with you.

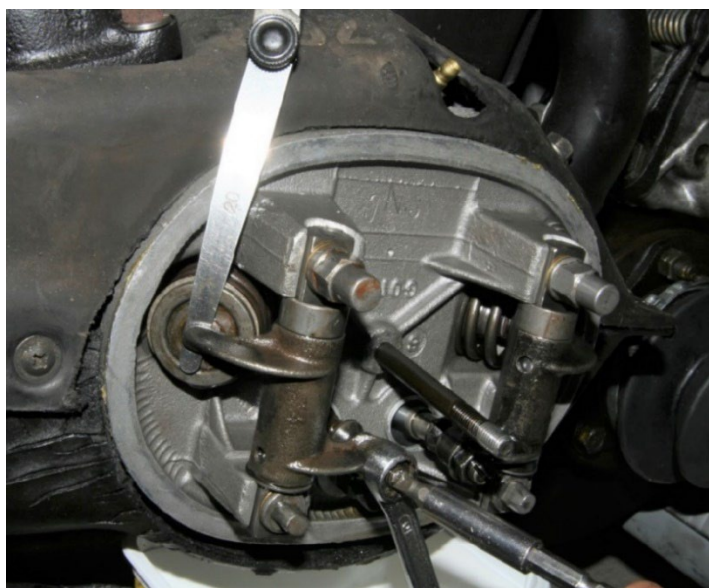
There was another item which hadn't been checked. Valve clearances. See photo at left. After the engine had fully cooled down, the rocker covers were removed. The head bolts seemed tight but were not further tightened (no torque wrench at hand). The valve clearances were checked, and this is what was found: the two inlet valves were exactly correct at 0.2mm, but both exhaust valves had not only presented with *zero* clearance, but were in fact being held open by some small amount, meaning they were never able to fully close. Definitely not good!

Normally, in the four-stroke engine cycle, the exhaust valves are opened near the bottom of the expansion/power stroke after most of the power from the burning/expanding gas has been extracted from the fuel mixture and converted into work by the pistons acting on the crankshaft.

However, with the exhaust valves always open at the point of ignition and on the expansion stroke, the valve faces and seats are being subjected to the blisteringly high temperatures of the burning mixture from the top to the bottom of the expansion stroke!

Further, the exhaust valves were receiving no cooling as they never came into contact with the valve seats. This would have resulted in the exhaust valves running at very high temperatures and potentially being destroyed. Definitely not good!

On analysis, I expect the large out of balance forces (the engine was pounding the engine mounts after it fired and until it reached idling speed) was because only one cylinder was firing during start up and idle because the other cylinder couldn't raise the necessary compression pressure required to ignite the fuel mixture because its exhaust valve was being held open for too long. However, it still managed to start on one cylinder which already had a held-open exhaust valve! How the car even started leaves me astounded. Above idling speed and up to driving speed, the (slightly) held-open exhaust valves would have had less effect on engine power, as by then, both cylinders would be firing and providing their part of the total engine power with plenty of air-fuel mixture being drawn in at the higher engine RPMs, so the small amount of mixture escaping during the compression and expansion strokes via the open exhaust valves, along with the reduced compression pressures, may not be easily noticed. If only one cylinder was operating at idle, it would help to explain why adjustment of the idle mixture screw had such little effect.

With the exhaust valves held open in this manner, the basic engine timing diagram (crankshaft angle vs valve open/close positions) was quite displaced from the correct settings. This, coupled with only one cylinder operating at idle, could well have caused the weird engine/manifold/exhaust note. It also means that instead of all the fuel-rich air mixture previously drawn in on the inlet stroke remaining in the cylinder to be compressed on the compression stroke, some of it was escaping (being pushed out) via the held-open exhaust valve and pushed into the exhaust manifold and cross box where it was later ignited in an explosive manner by the next burst of hot burnt gasses discharged on the following exhaust stroke. This too would have changed the engine sound.

It seems very odd that the inlet valve clearances were on specification but the exhaust valve clearances had not only closed up to zero so the rocker arms were always in contact with the valve stems, but the adjustment screws had been positioned even further inwards (clockwise) to where the valves were no longer able to close. The adjusting lock nuts appeared to be tight!

Could it have been due to the locknuts not being adequately tightened, allowing/causing the rocker adjustment screws to rotate in a clockwise direction under the influence of the net mechanical forces at work, driving the valves further out of the heads. Perhaps it was only because the locknuts had tightened up that prevented the valves being pushed even further into the combustion space, and into the domain of the piston!! I'm at a loss to explain how this situation could arise if the exhaust valves had been set correctly last time they were adjusted.

After setting the exhaust valve clearances to 0.2mm, the rocker covers and nuts were refitted hand tight, then a further one and one-half turns with the spanner. The idle mixture screw was set to three and one half turns outwards (counter-clockwise) from being (gently!) seated. The engine started immediately, and the strange engine sound had gone. After checking there were no oil leaks from the rocker cover gaskets, the idle speed was adjusted to 825 RPM in conjunction with adjustment of the idle mixture screw. The oil was topped up. All seemed fine as far as could be determined.

In summary, at each annual service, set the valve clearances. It only takes a few minutes. Refer to the writer's article, *2CV Valve Clearance Adjustment* for the complete procedure.

If unsure when the valve clearances were last set, *do this task now as a matter of urgency*. It won't take you long. Also, using multi-use rocker cover gaskets makes the job even easier.

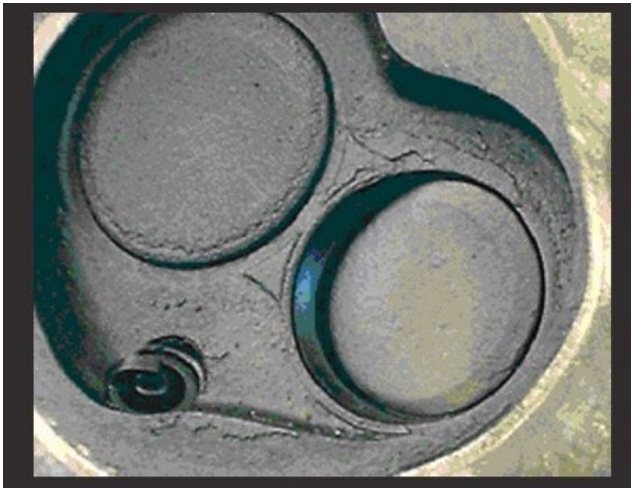
Is exhaust valve recession the underlying cause of the loss of exhaust valve clearance? The symptoms could certainly indicate that. The valves could still have been held open whether seat recession had occurred or not, so it's not clear.

This implies hardened exhaust valve seats were used in 602cc engines. If this is the case, then it's most unlikely to be exhaust valve recession, but it still could be. The engine heads will require removal and inspection. The valve at the lower right in the photo at left (not a 2CV) has a bad case of valve recession. The valve seat has worn away quite severely, allowing the valve to sit quite deeply into the head. A head repair *will* be needed to fit at least one new valve seat and one new valve.
