2CV CARBURETTOR COVER SCREWS

Revision 3

By Graeme Dennes

This article applies to the dual-choke carburettor fitted to the 2CV from 1978 onwards.

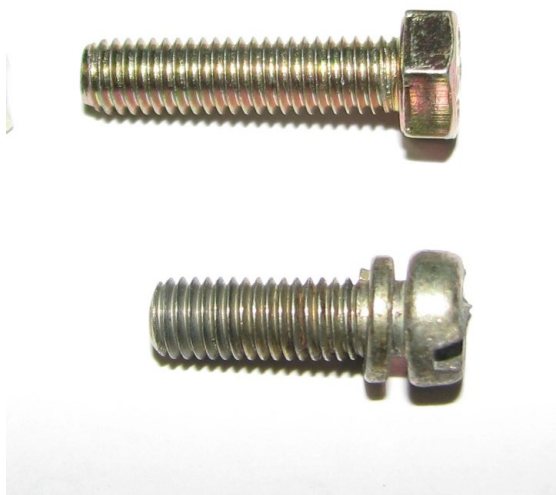
PHOTO 1

At bottom of Photo 1 is a standard Solex M5 x 0.8 x 15 screw with its fitted split washer, alongside an M5 x 0.8 x 20 replacement screw (hex headed bolt).

For my green "English" 2CV, which was fitted with 0.8mm threads (yes, ISO threads!), I made up a set of six custom-length M5 x 0.8 "screws" from hex-headed bolts with a screwdriver slot neatly cut in the heads. Each screw was cut to the maximum length allowable for each position, which provided for the correct sealing between the top cover and the body, and the longest maintenance life of the carburettor body threads. Don't forget to add a split washer under each screw head, and always return each screw to the same position.

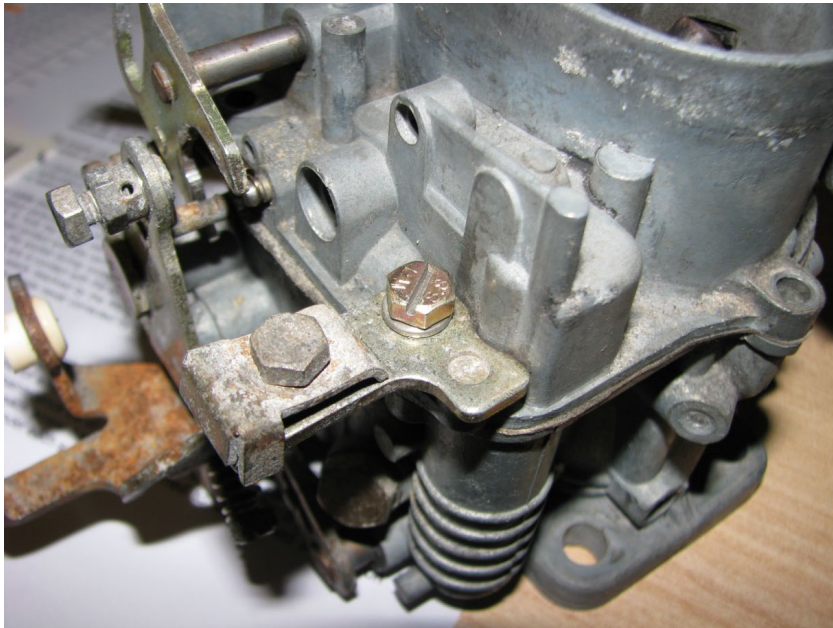
PHOTO 2

The standard carburettor top cover screws are typically 15mm in length. However, the screw which does double duty to hold the choke cable mounting bracket should be around 22mm in length (but no longer) to maximise thread contact with the carburettor body. The effect of this 7mm shortfall is the eventual stripping of the threads in the body socket during normal carburettor maintenance activities because only about *one third* of the carburettor body threads engage with the screw. A helicoil repair will be needed if the threads are stripped. The problem may be easily resolved by fitting a 22mm length screw of the *same* thread type as the original. It seems this issue was never corrected by Citroen. Again, Wilson Carburettor Service can provide the 22mm screw.

Photo 2 shows the new M5 x 0.8 x 22 screw fitted to the choke cable mounting bracket position. Note the slot cut in the head for a screwdriver.

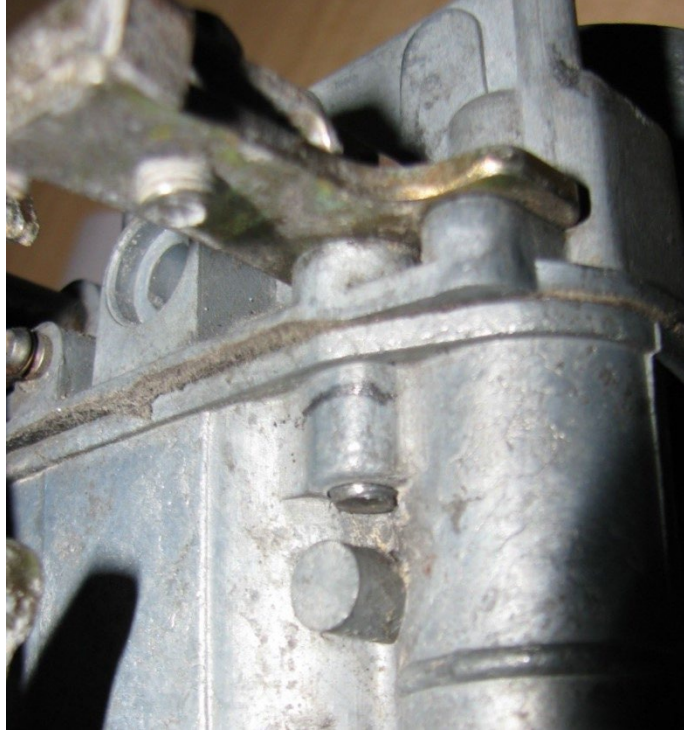
PHOTO 3

Photo 3 shows a side view of the choke cable mounting bracket, with the new M5 x 0.8 x 22 screw in position. Note the end of the screw just projecting outside of the lower opening of the carburettor body socket (centre of photo), ensuring the maximum number of engaged threads is being utilised. Ensure all new screws are not *too* long to cause binding against the carburettor body, else more stripped threads will result.
