2CV SECONDARY CHOKE
BUTTERFLY ADJUSTMENT
Revision 5

2CV SECONDARY CHOKE BUTTERFLY ADJUSTMENT

Revision 5

By Graeme Dennes

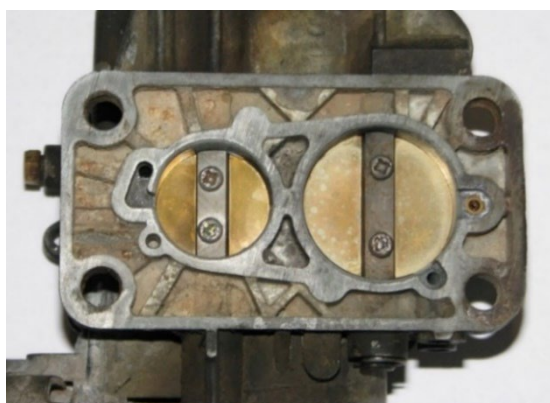
Photo 1 shows the underneath of the carburettor with the throttle at the idle position. The barely open (smaller) butterfly on the left controls the quantity of air/fuel mixture delivered by the (smaller) primary choke, while the larger butterfly on the right controls the quantity of mixture delivered by the larger secondary choke, the source of the 2CV's unbridled power! Um, unbridled *what...??*

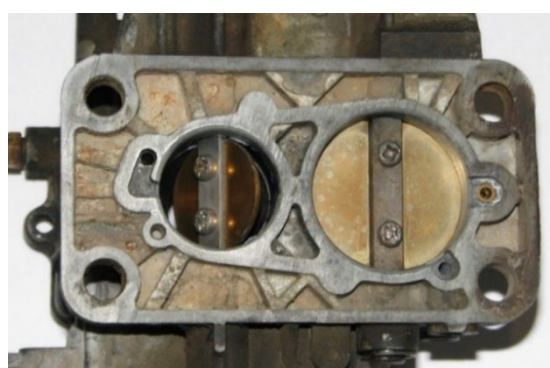
Photo 2 shows the butterflies as they appear with a partially open throttle. The primary choke butterfly on the left is around half open, while the secondary choke butterfly on the right is (still) closed. In fact, the secondary butterfly remains closed until around half throttle, after which it starts to open. Both butterflies reach maximum opening at full throttle.

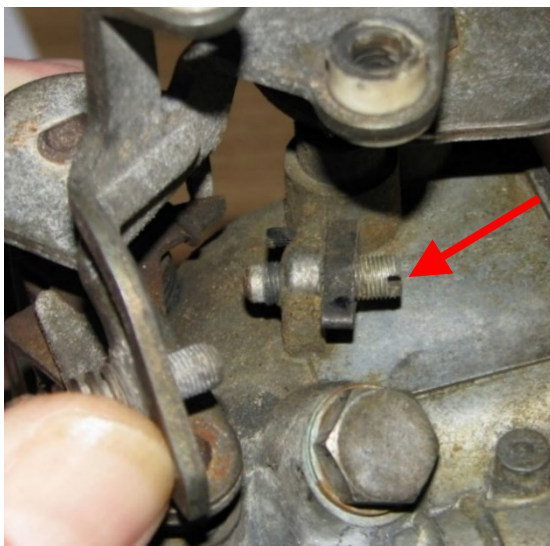
Photo 3 below shows the secondary choke butterfly adjustment screw in the centre of the photo. Note the small spring clip fitted to it to ensure it does not move. The throttle is being held in the fully open position.

6. If the secondary choke butterfly adjustment screw is fitted with an anti-tamper cap, remove the cap to expose the slotted screw head. In Photos 3 and 4, the cap has been removed.

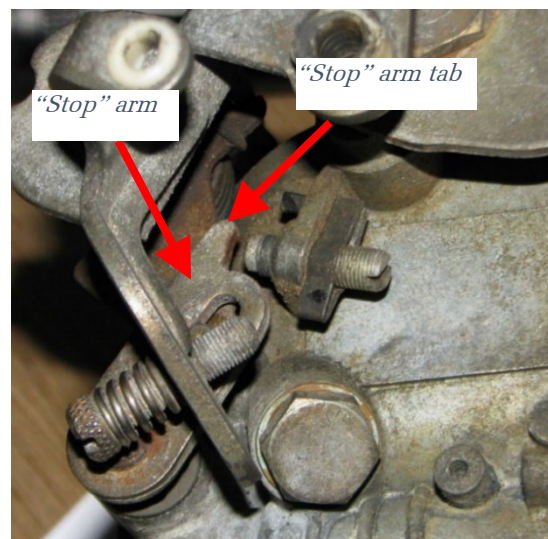
Photo 4 shows the "stop" arm which is attached to the secondary choke butterfly shaft. It's the partially hidden, slotted, elongated metal fitting positioned behind the idle speed adjustment screw and spring at the lower left. For clarity, the butterfly adjustment screw has been unscrewed several turns so its tip is well clear of the tab on the end of the "stop" arm.

7. With the throttle fully closed, turn the secondary butterfly adjustment screw anti-clockwise five turns so its tip is **well clear** of the “stop” arm tab, as per Photo 4.

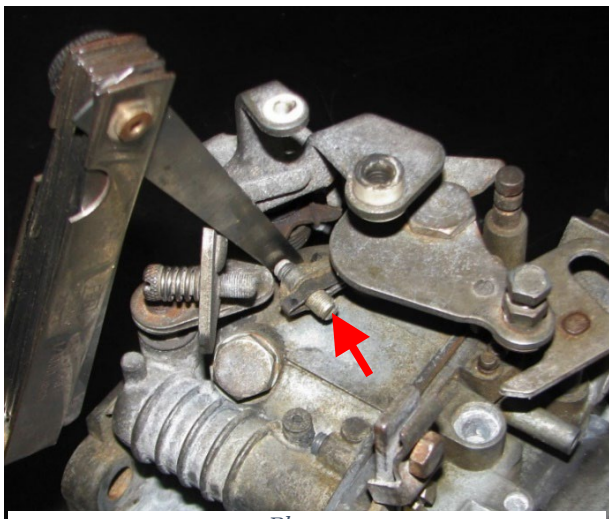
Recent analysis by the writer identifies how! See Photo 5 on left. At idle, the secondary butterfly adjustment screw (arrowed) is adjusted with a feeler gauge to provide a clearance of **0.2mm** between the tip of the secondary butterfly adjustment screw and the tab on the "stop" arm. That's it! All done! Ship it out!

9. With the carburettor in the idle position, adjust the secondary choke butterfly adjustment screw until a **0.2mm** feeler gauge just fits nicely between the tab on the “stop” arm and the tip of the adjustment screw per Photo 5. It should be a smooth sliding fit, not a tight fit or a loose fit. “Snap” the throttle by hand a few more times, then recheck the clearance. Snap some more and recheck. And again. Setting the **0.2mm** clearance while the secondary butterfly is properly closing off the secondary choke *is the most important part of the entire procedure.*
