2CV SECONDARY CHOKE BUTTERFLY ADJUSTMENT

Revision 6

Graeme Dennes

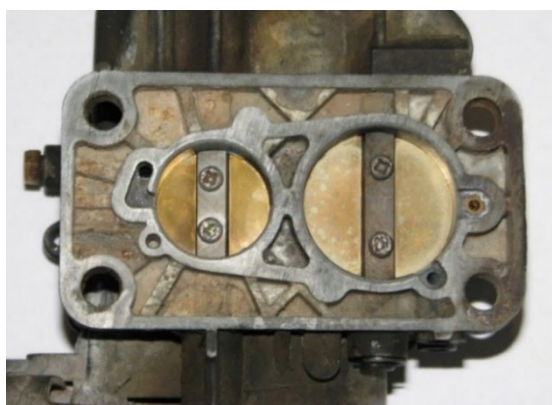
Photo 1 shows the underneath of the carburettor with the throttle at the idle position. The barely open (smaller) butterfly on the left controls the quantity of air/fuel mixture delivered by the (smaller) primary choke, while the larger butterfly on the right controls the quantity of mixture delivered by the larger secondary choke, the source of the 2CV's unbridled power! Um, unbridled *what...??*

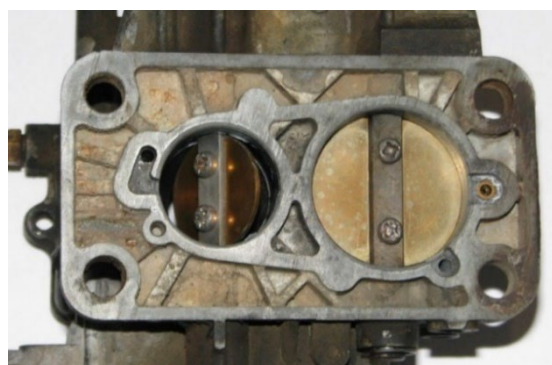
Photo 2 shows the butterflies as they appear with a partially open throttle. The primary choke butterfly on the left is around half open, while the secondary choke butterfly on the right is (still) closed. In fact, the secondary butterfly remains closed until around half throttle, after which it starts to open. Both butterflies reach maximum opening at full throttle.

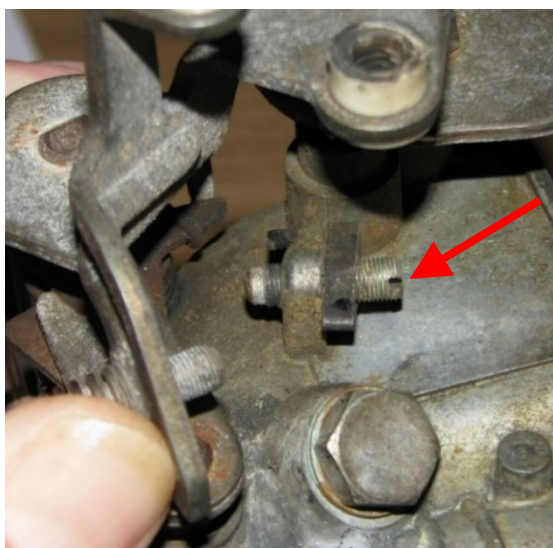
Photo 3 below shows the secondary choke butterfly adjustment screw in the centre of the photo. Note the small spring clip fitted to it to ensure it does not move. The throttle is being held in the fully open position.

6. If the secondary choke butterfly adjustment screw is fitted with an anti-tamper cap, remove the cap to expose the slotted screw head. In Photos 3 and 4, the cap has been removed.

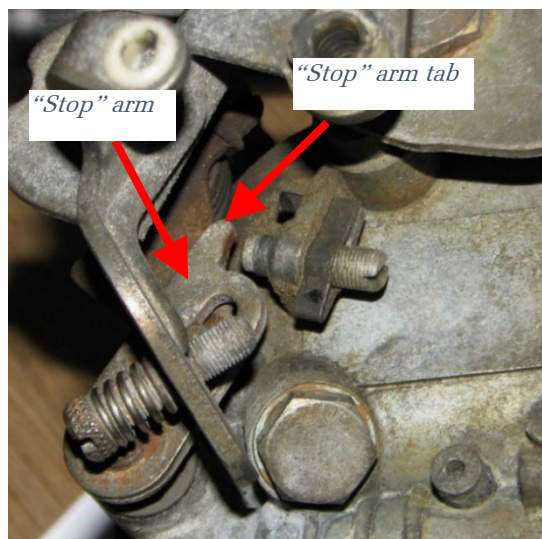
Photo 4 shows the "stop" arm which is attached to the secondary choke butterfly shaft. It's the partially hidden, slotted, elongated metal fitting positioned behind the idle speed adjustment screw and spring at the lower left. For clarity, the butterfly adjustment screw has been unscrewed several turns so its tip is well clear of the tab on the end of the "stop" arm.

7. With the throttle fully closed, turn the secondary butterfly adjustment screw anti-clockwise five turns so its tip is **well clear** of the “stop” arm tab, as per Photo 4.

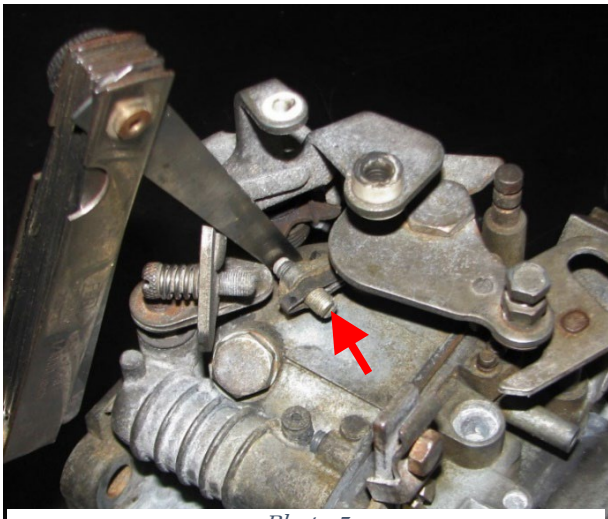
Recent analysis by the writer identifies how! See Photo 5 on left. At idle, the secondary butterfly adjustment screw (arrowed) is adjusted with a feeler gauge to provide a clearance of **0.2mm** between the tip of the secondary butterfly adjustment screw and the tab on the "stop" arm. That's it! All done! Ship it out!

9. With the carburettor in the idle position, adjust the secondary choke butterfly adjustment screw until a **0.2mm** feeler gauge just fits nicely between the tab on the “stop” arm and the tip of the adjustment screw per Photo 5. It should be a smooth sliding fit, not a tight fit or a loose fit. “Snap” the throttle by hand a few more times, then recheck the clearance. Snap some more and recheck. And again. Setting the **0.2mm** clearance while the secondary butterfly is properly closing off the secondary choke *is the most important part of the entire procedure.*
