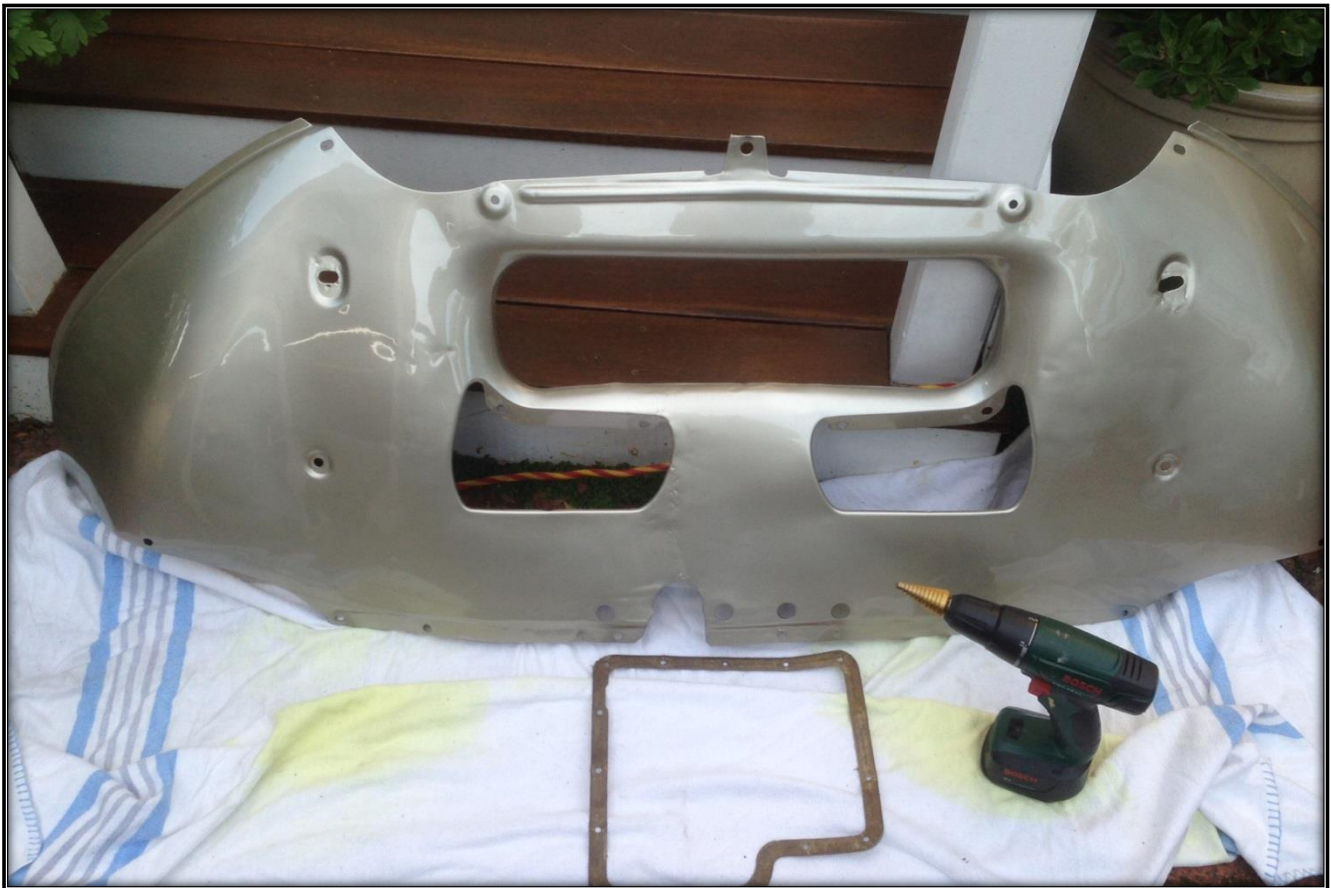
The front valance on the DS was not modified when the Borg Warner-35 transmission was fitted. It's a real nuisance having to remove the valance to access some of the bolts on the transmission filter cover plate.

With the valance in place use a marker pen and ruler to carefully mark the position of the four bolt heads that are inaccessible. Remove the valance.

After draining the oil, undo the cover plate, remove the old gasket and use it to mark out the bolt spacing more accurately in accordance to the marks you made earlier. Centre-punch the locations and drill pilot holes. Using a tree-bit, drill 20mm holes in the marked locations. The holes will be large enough to fit an 11mm socket. To renew the gasket you can buy cork gasket material in a roll and cut it to order. You will need a hole-punch of course. No gasket cement is needed.
