# 2CV GEARBOX OUTPUT HUBS

## Revision 4

By Graeme Dennes

This article describes the procedure to replace the oil seals, and optionally, the bearings, in the 2CV gearbox output hubs. The critical items associated with the procedure are described. The article commences with background information and an overview of the procedure.

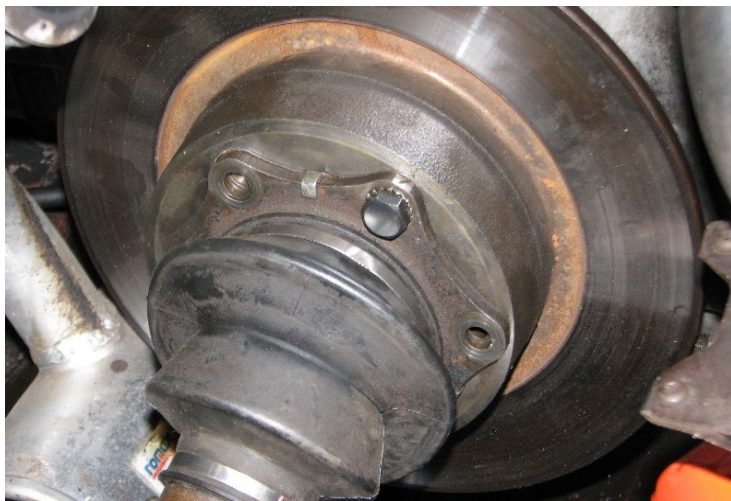
**Photo 2:** Crikey. Looks like I got to this job just in time! (Only joking. That single bolt was fitted for the photo!)

Shows a closer view of the inner CV-joint plate and brake disc still bolted to the drive flange on the output hub (the hub is still hidden behind the disc).

You may observe a small bent metal clip situated between the two upper bolt positions. There are three of these clips positioned on the CV-joint plate

and they hold in place what is essentially a shaped metal gasket.

The metal gasket fits between the CV-joint plate and the outer face of the brake disc. The metal gasket normally won't be loose and fall off, but ensure it is properly fitted and secured before the CV-joint plate and brake disc are later refitted to the output hub with the six bolts.

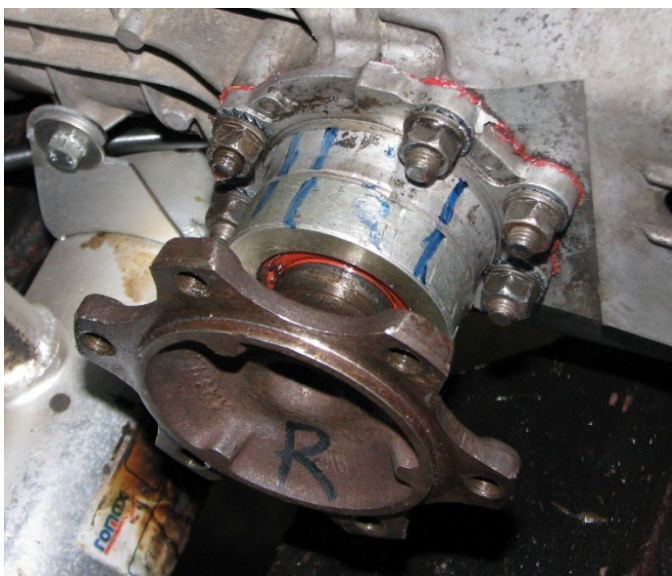
**Photo 5:** Another view of the gearbox output hub, showing the hub and its mounting flange which is held on the gearbox by six studs, nuts and star washers. A thin paper gasket (with gasket sealant on *both* sides) fits between the hub mounting flange and the gearbox face. The excess gasket sealant is shown in orange at the upper part of the photo.

Note: The orange colour at the centre of the photo is part of the face of the sealed

outer shaft bearing, mostly hidden by the ring nut. (The *inner* shaft bearing is inside the gearbox.) Note: Citroen refers to the ring nut as a bush nut. The output hub shaft extends outwards from the hub and is flared to form the metal drive flange which holds the six bolts for attaching the brake disc and the CV-joint plate fitted to the front wheel drive shaft.

**Critical item:** If gasket sealant is not applied, the joint will leak!

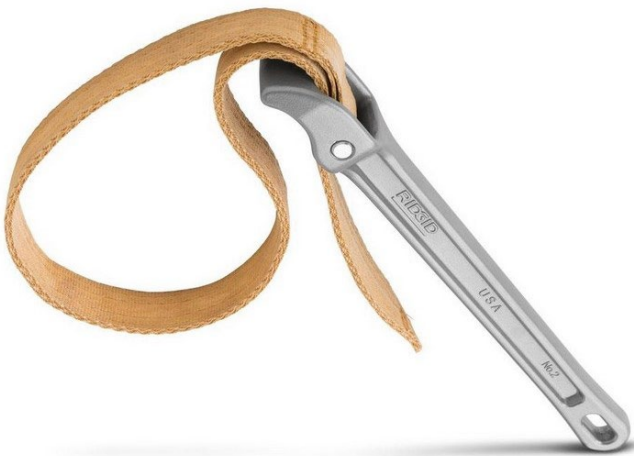
**Photo 7:** Strap spanner. Used for unscrewing the ring nut from the hub body. It is also used for tightening the ring nut during reassembly of the hub.

This particular tool is made by Ridgid and uses a resin-impregnated nylon strap about 30 mm wide. It is *very* strong!

As noted, should the strap spanner be unable to loosen the ring nut and unscrew it, a cold chisel and hammer will be required to firstly cut a notch in the ring nut and then to drive the ring nut counter-clockwise to unscrew it.

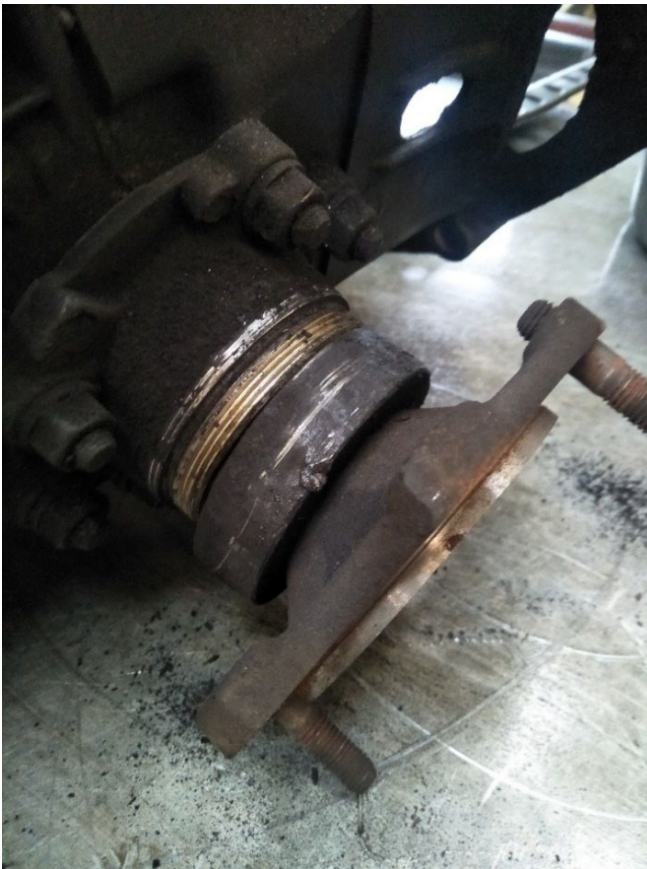
**Photo 9:** This “thousand words” photo shows the unscrewed ring nut and the mating threads on the hub body. *The ring nut is a threaded cap which holds the output hub shaft and the bearing captive in the hub body.*

A point of interest in Photo 9 is that this particular output shaft drive flange has been fitted with double-ended studs. In theory, this should give a longer life to the drive flange threads because the usual six bolts are not being repeatedly tightened into the drive flange, so should a thread ever be damaged, it is a simple job to replace a stud while extending the life of the drive flange. (Photo 9 courtesy of Peter Fosselius).

Note the small notch cut into the outside edge of the ring nut with a cold chisel as already mentioned. **With the output hub still attached to the gearbox casing,** start with a *sharpened* cold chisel and a hammer to cut a small notch at around 11.30 on the ring nut. The cold chisel needs some amount of angle to firstly bite into the ring nut to cut the notch but it then has to be able to start it turning until it loosens. The cold chisel will open the peening in the ring nut and allow the ring nut to start turning counter-clockwise. There’s not much room to swing the hammer. A short-handled heavy hammer works best. Once the notch is cut, use a *less-sharp* cold

chisel so it *pushes* on the metal of the shoulder of the notch rather than cutting deeper into it. You will need to use your best judgement at every step with this task as it is too hard to specify.

**Note:** Don’t destroy the shoulder or you’ll need to cut another notch! If the ring nut is still quite tight, you may need to cut a second notch to keep the ring nut turning further until it loosens enough for the strap spanner to remove it. If the ring nut won’t budge at all, some heat may be applied directly to the ring nut (but nowhere else!), immediately followed by the cold chisel and hammer. The peening does not interfere with the threads on the hub body or the ring nut.

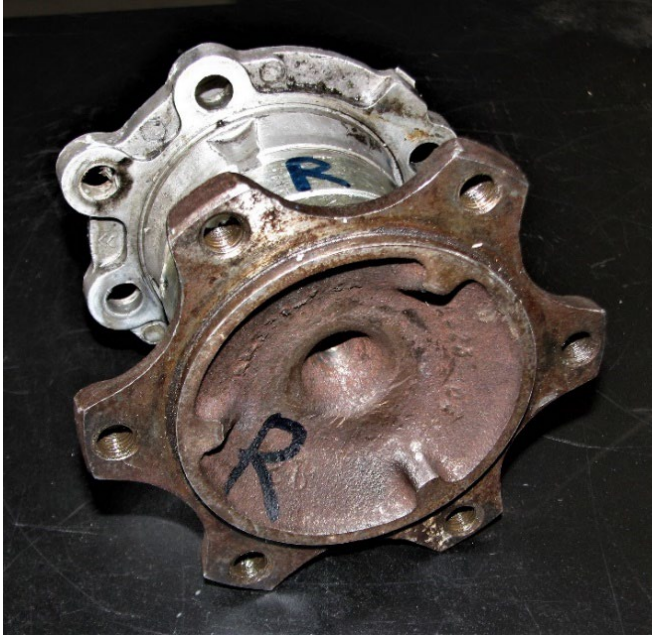
**Photo 12:** Ah, found it! Another view of the output hub, showing the third “R” on the drive flange of the output hub shaft.

To repeat, keep the three items marked with an “R” and the steel shims as a matched set, in this case, for the right side. Do the same for the left-side items. This is vital.

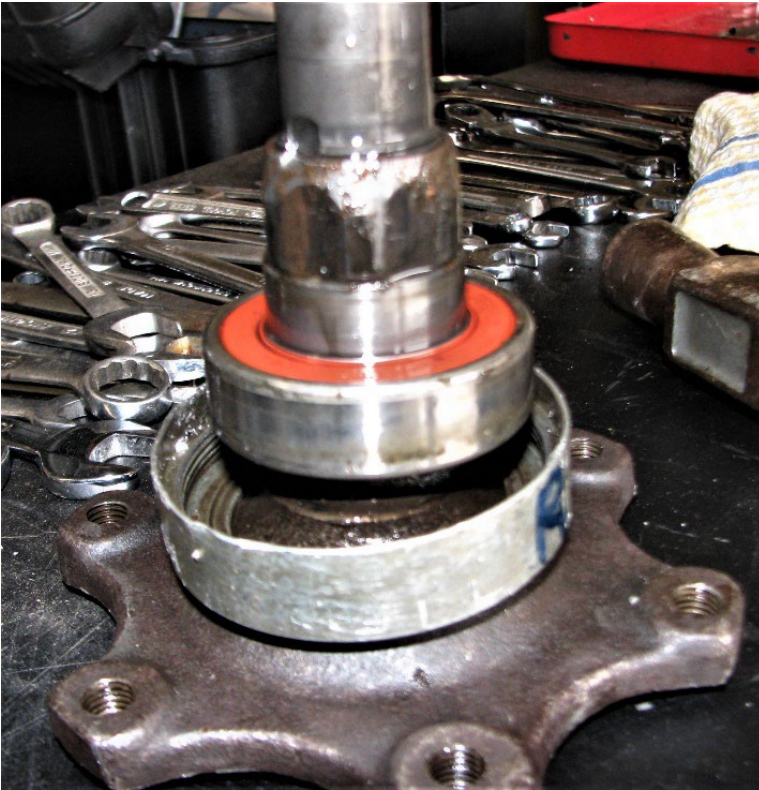
**Photo 17:** The output hub shaft assembly after being withdrawn from the hub. Shows the shaft, the lock nut, the steel spacer, the sealed bearing, the unscrewed ring nut and the output shaft drive flange.

The bearing, which is pressed onto the shaft, is size **25x52x15 mm** and is a lifetime sealed type.

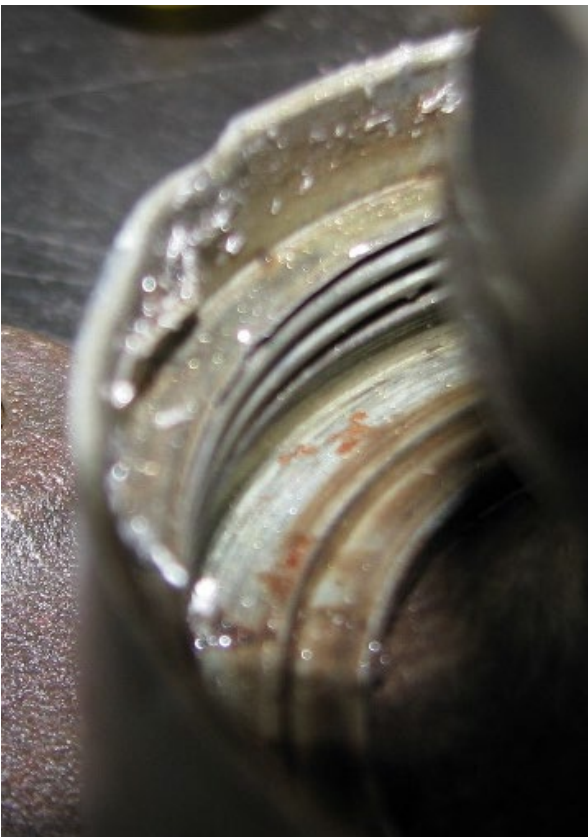
**Photo 18:** A close-up of the inside threads in the ring nut.

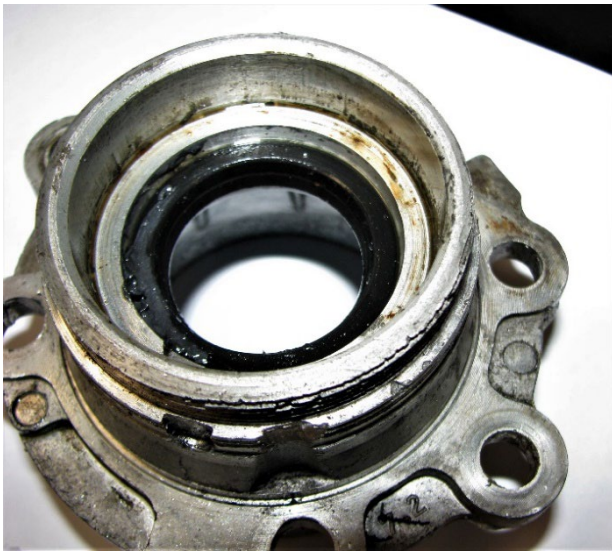
**Photo 19:** Shows the output hub oil seal of size 31x42x8 mm. Fitted from the outer end of the hub (upper-most opening in the photo). The open side of the seal (with the rubber lip and spring) faces downwards in the photo, i.e. **towards** the gearbox.

Remove the old oil seal and clean the hub thoroughly. Apply rubber grease to **all** metal surfaces of the hub which will come into contact with the new oil seal.

Apply rubber grease to all surfaces of the new oil seal and fit the seal into position in the hub.

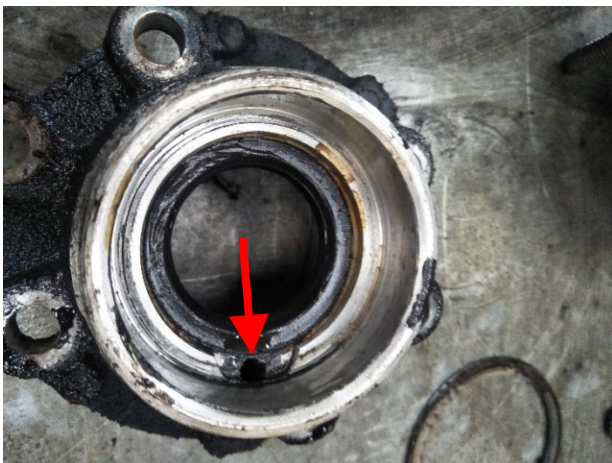
**Photo 21** above left shows the oil drain hole located at the **bottom** of the hub bearing housing.

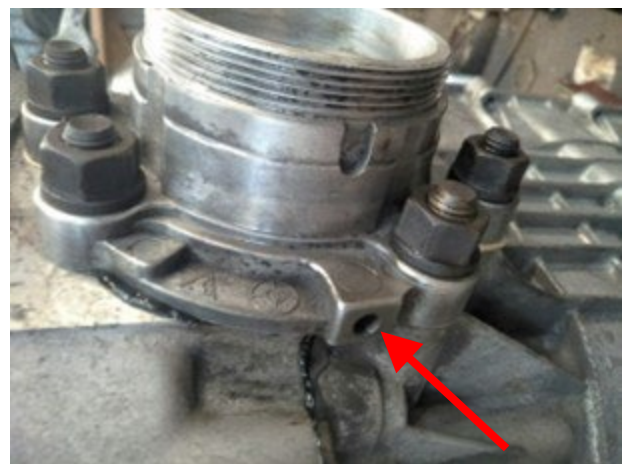
Any oil escaping past the shaft oil seal (shown in the centre of the hub) passes down through the oil drain hole and exits the hub from the oil drain hole located at the lower rear edge of the hub mounting flange as shown in **Photo 22** above right. The oil drain hole is arrowed. Photo 22 also shows one of the hub body peening detents for peening the edge of the ring nut. (Both photos courtesy of Peter Fosselius).

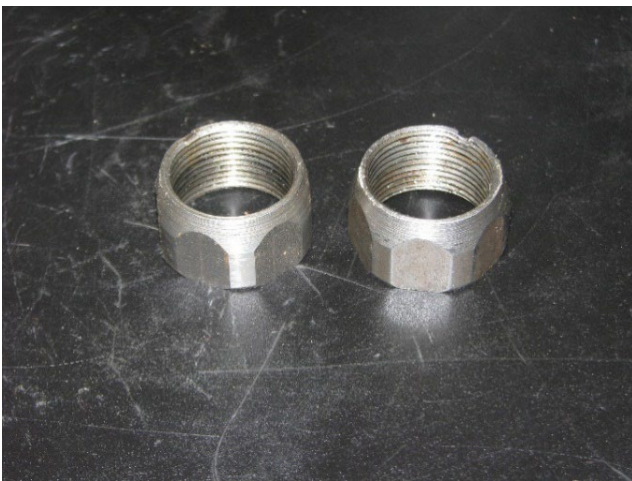
**Photo 24:** The lock nuts on the output hub shafts. These are tightened to **75 foot-pounds**. Add some copper grease first. The upper edge of each nut is peened into the opening in the shaft before the hub is finally reassembled and returned to the vehicle. The previous peening points are shown on the nuts. Ensure everything is spotlessly clean.

*If the lock nuts need to be removed, swap them over between the two hubs so the peening points will (very likely) be in different positions on the nuts.*
