# 2CV BRAKE SAGA

# THE TALE OF THE DUCK THAT ALMOST COOKED ITS GOOSE

The following sequence of events occurred with our 1974 orange 2CV (Duck à l'orange) after it had undergone a brake system "transplant" to convert it from a drum-brake DOT 4 system to a disc-brake LHM system. The physical changeover of the front drums to discs had its own set of issues with the drive hubs on the gearbox which were eventually resolved.

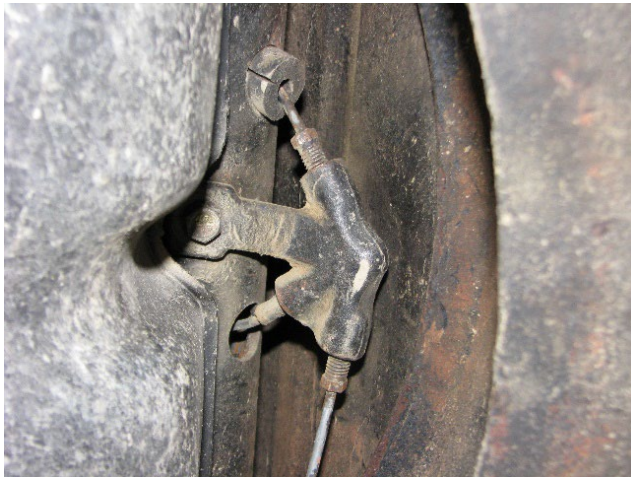
4. Fitted new LHM brake line rubber seals in the rear wheel brake line union. (This is the brake line splitter which feeds the fluid from the master cylinder to the two rear wheel cylinders. Located high up at the top/front edge of the fuel tank.)

*Figure 1 Rear brake line union, next to fuel tank*

26. Perhaps the old brake line rubber seals in the rear brake line union had broken up a little and were partially blocking the return fluid flow to the master cylinder, resulting in the 10-second retraction time of the master cylinder piston. The union had previously been subjected to three hours of high heat to enable the three brake line fittings to be removed. Perhaps the seals had been untouched since the car was new 43 years prior. Still, this symptom was not there previously.

27. Thus, decided to again remove and thoroughly check/clean the rear brake line union for partial blockage, just to be sure. Nothing was found to constrict the fluid flow inside the metal union. All clear. Three new LHM brake line rubber seals were fitted and all three fittings done up securely. No problems there. However, the weak fluid flow during bleeding operations remained, as did the 10-second delay in retraction of the master cylinder piston, so I presumed the roadside brake lock-up problem was also still a possibility.

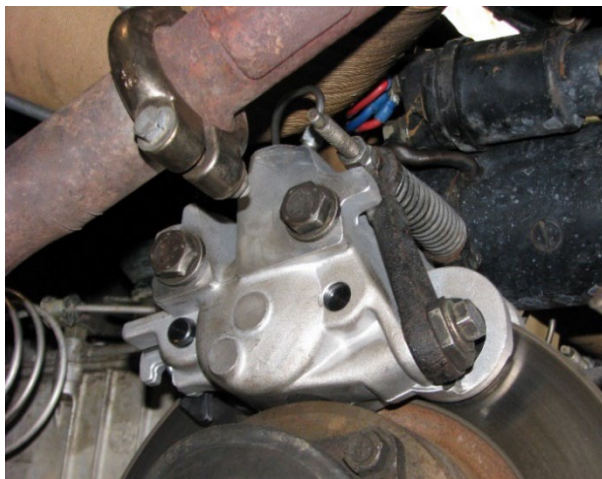
1. Fitted new LHM dual-circuit master brake cylinder, new LHM rubber seals for the fluid reservoir, a new fluid reservoir and new brake line seals at the master cylinder.
2. Fitted pre-loved disc brake calipers after installing new pistons, new LHM rubber piston seals and dust seals, new LHM rubber O-rings between the two caliper halves, new LHM brake line rubber seals on all brake line fittings, and a new bleed nipple on the left caliper, just to be sure.

*Figure 2 One of the new calipers*

29. Could it be caused by (unstable) corrosion build-up in the fluid path inside the pre-loved brake calipers, causing poor fluid flow from the calipers? Still, there is so very little fluid flow to/from the calipers as the pistons are "in contact" with the brake pads at all times. However, the calipers were previously heavily corroded around the piston surfaces and it took a considerable effort (some hours) of much heat, pressure and gratuitous verbal advice to remove the old pistons. But then, this shouldn't cause poor fluid flow from the rear bleed nipples as there is no connection between the two hydraulic circuits.

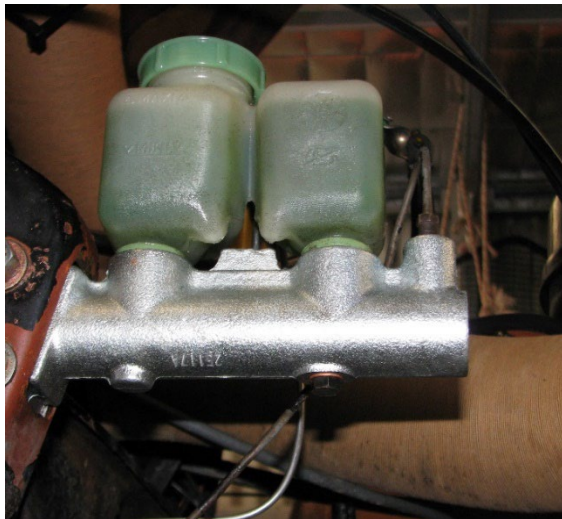
14. Logically, the symptoms point to a faulty brake master cylinder, although it was brand new.

*Figure 3 New brake master cylinder and reservoir*

Yes, two brand new master cylinders of different brands and different part numbers from different major European spare parts suppliers were faulty, with weird but not totally dissimilar symptoms. They were physically different products and with completely different packaging - brand, colours, part numbers, labels, barcodes, etc.

35. So in a true and final act of crash-and-burn defiance and desperation, the known good master cylinder in the green car was removed and fitted to the orange car. Yep, the third master cylinder!

36. The brakes were bled. In short, (cover your ears!!!) – Eureka. Eureka! Eureka! The bleeding operation was instantly successful and totally normal, the pedal feel was absolutely normal, and the pedal returned instantly to its fully-out position when the foot was lifted. No wheels remained locked up. Everything felt and acted normal. Still, it still needs a test drive to confirm that all is finally correct.
