2CV BRAKE SAGA

Revision 4

THE TALE OF THE DUCK THAT ALMOST COOKED ITS GOOSE

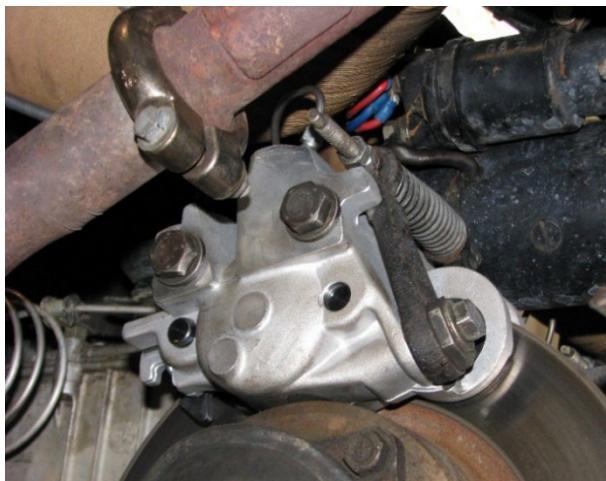
1. Fitted new LHM dual-circuit master brake cylinder, new LHM rubber seals for the fluid reservoir, a new fluid reservoir and new brake line seals at the master cylinder.
2. Fitted pre-loved disc brake calipers after installing new pistons, new LHM rubber piston seals and dust seals, new LHM rubber O-rings between the two caliper halves, new LHM brake line rubber seals on all brake line fittings, and a new bleed nipple on the left caliper, just to be sure.

Figure 2 One of the new calipers

29. Could it be caused by (unstable) corrosion build-up in the fluid path inside the pre-loved brake calipers, causing poor fluid flow from the calipers? Still, there is so very little fluid flow to/from the calipers as the pistons are "in contact" with the brake pads at all times. However, the calipers were previously heavily corroded around the piston surfaces and it took a considerable effort (some hours) of much heat, pressure and gratuitous verbal advice to remove the old pistons. But then, this shouldn't cause poor fluid flow from the rear bleed nipples as there is no connection between the two hydraulic circuits...

32. So as a desperate man now, and in complete disbandment of all logical diagnostic reasoning for doing so, I decided to remove the known good brake calipers from our green car and fit them to the orange car. What else could it be? There are only so many items in the brake system, and I'd already attended to them ALL, and some more than once!!!

33. After the "new" calipers were fitted, the system was bled again. There wasn't much change to the bleeding behaviour, and the pedal still took several seconds to fully return. In summary? No change at all. Ok, so it's not the calipers. (The temperature's risin' and the juke box is about to blow the fuse!).

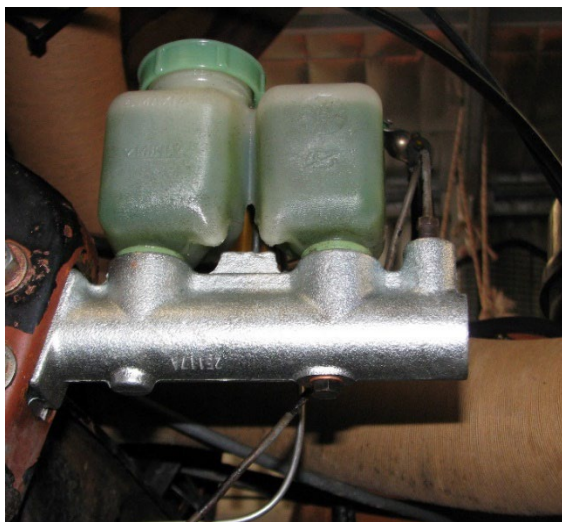
18. However, a new problem has appeared. When the brake pedal is released, the brake pedal (and master cylinder piston) was taking about 10 seconds to return to the fully out (brakes off) position, whereas it should return instantly.

Figure 3 New brake master cylinder and reservoir

14. Logically, the symptoms point to a faulty brake master cylinder, although it was brand new.
15. Ordered and received a second new LHM dual-circuit master brake cylinder from a different European supplier and fitted it to car.

35. So in a true and final act of crash-and-burn defiance and desperation, the known good master cylinder in the green car was removed and fitted to the orange car. Yep, the third master cylinder!

36. The brakes were bled. In short, (cover your ears!!!) – Eureka. Eureka! Eureka! The bleeding operation was instantly successful and totally normal, the pedal feel was absolutely normal, and the pedal returned instantly to its fully-out position when the foot was lifted. No wheels remained locked up. Everything felt and acted normal. Still, it still needs a test drive to confirm that all is finally correct.
