2CV GEARBOX OUTPUT HUBS

Revision 5

Graeme Dennes

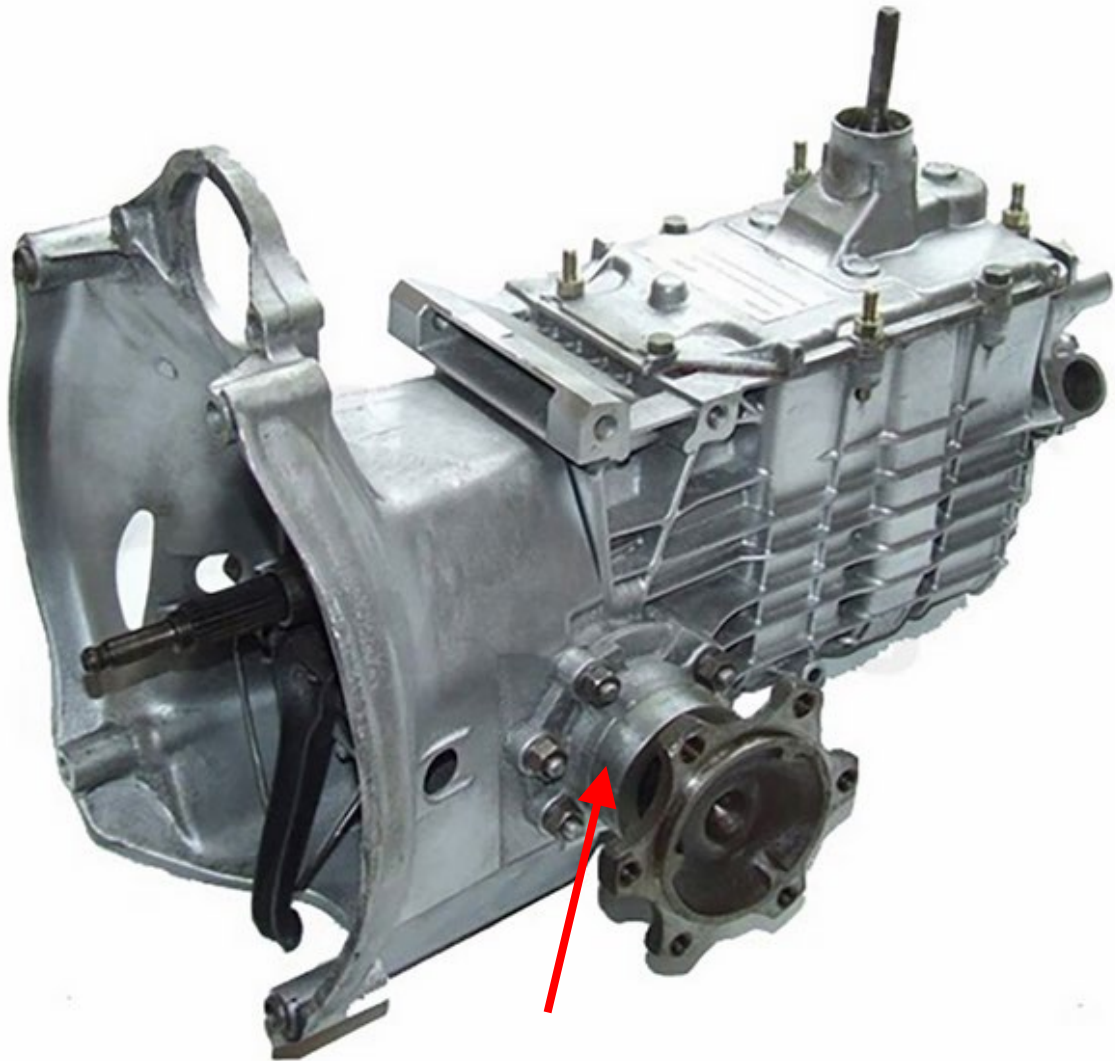
2CV Gearbox showing the left-side output hub (arrowed)

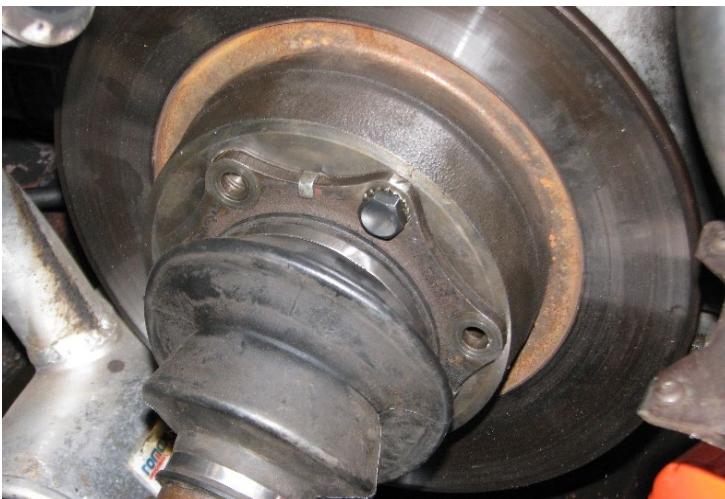
Photo 2: Crikey. Looks like I got to this job just in time! (Only joking. That single bolt was fitted for the photo!)

Shows a closer view of the inner CV-joint plate and brake disc still bolted to the drive flange on the output hub (the hub is still hidden behind the disc).

You may observe a small bent metal clip situated between the two upper bolt positions. There are three of these clips positioned on the CV-joint plate

and they hold in place what is essentially a shaped metal gasket.

The metal gasket fits between the CV-joint plate and the outer face of the brake disc. The metal gasket normally won't be loose and fall off, but ensure it is properly fitted and secured before the CV-joint plate and brake disc are later refitted to the output hub with the six bolts.

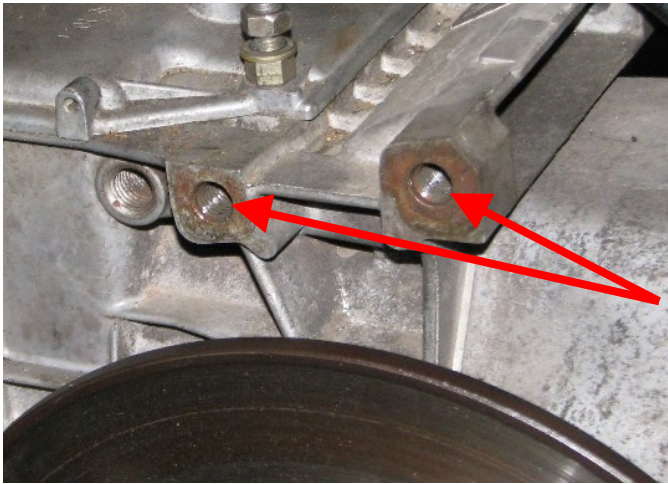
Photo 3: Shows the attachment points for the brake caliper bolts on the right side of the gearbox. The caliper bolts hold the thin metal shim and the brake calipers in place.

An item of interest. Should you plan to replace your DOT drum brake system with an LHM disc brake system, ensure your gearbox has these two caliper bolt mounting holes, otherwise the changeover cannot be done!

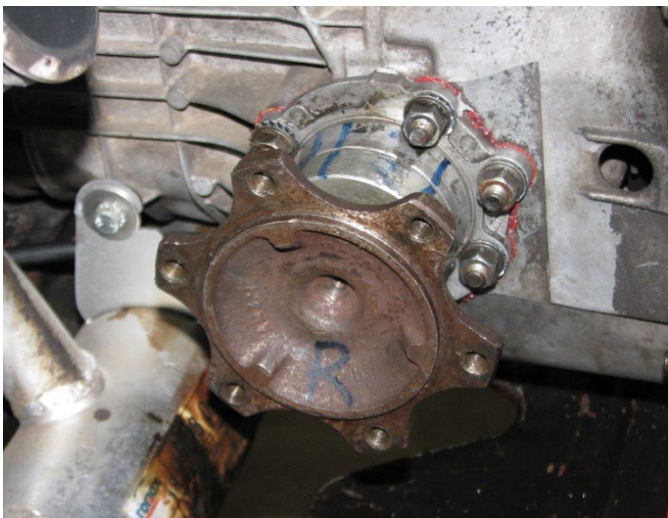
Photo 4: Ladies and gentlemen. Please take your seats. After the CV-joint plate and brake disc are removed from the output hub drive flange, the output hub is exposed in all its glory! The photo shows the flared drive flange on the output hub with its six bolt attachment points. Note the blue "R" (for the right side). Yes, many 2CV owners never get to see the output hubs because they are highly-reliable, long-lasting components which are mostly hidden from sight by the brake components of the 2CV.

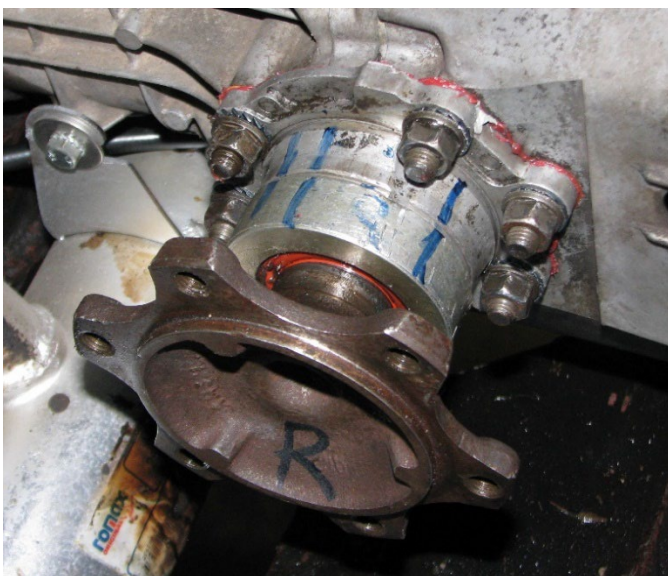
Photo 5: Another view of the gearbox output hub, showing the hub and its mounting flange which is held on the gearbox by six studs, nuts and star washers. A thin paper gasket (with gasket sealant on *both* sides) fits between the hub mounting flange and the gearbox face. The excess gasket sealant is shown in orange at the upper part of the photo.

Critical item: If gasket sealant is not applied, the joint will leak!

Note: The orange colour at the centre of the photo is part of the face of the sealed

outer shaft bearing, mostly hidden by the ring nut. (The *inner* shaft bearing is inside the gearbox.) Note: Citroen refers to the ring nut as a bush nut. The output hub shaft extends outwards from the hub and is flared to form the metal drive flange which holds the six bolts for attaching the brake disc and the CV-joint plate fitted to the front wheel drive shaft.

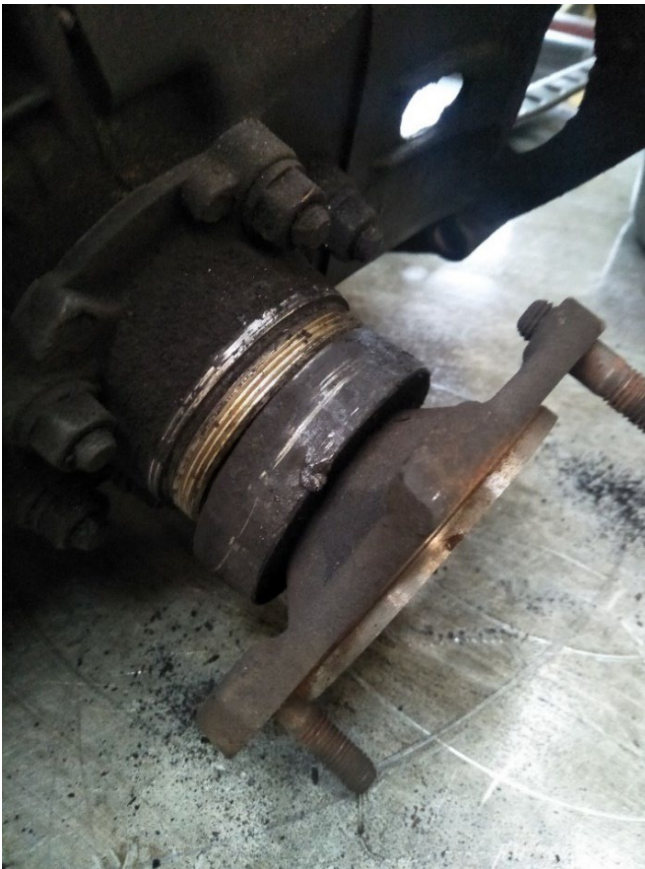
Photo 9: This “thousand words” photo shows the unscrewed ring nut and the mating threads on the hub body. *The ring nut is a threaded cap which holds the output hub shaft and the bearing captive in the hub body.*

Note the small notch cut into the outside edge of the ring nut with a cold chisel as already mentioned. **With the output hub still attached to the gearbox casing,** start with a *sharpened* cold chisel and a hammer to cut a small notch at around 11.30 on the ring nut. The cold chisel needs some amount of angle to firstly bite into the ring nut to cut the notch but it then has to be able to start it turning until it loosens. The cold chisel will open the peening in the ring nut and allow the ring nut to start turning counter-clockwise. There’s not much room to swing the hammer. A short-handled heavy hammer works best. Once the notch is cut, use a *less-sharp* cold

chisel so it *pushes* on the metal of the shoulder of the notch rather than cutting deeper into it. You will need to use your best judgement at every step with this task as it is too hard to specify.

Note: Don’t destroy the shoulder or you’ll need to cut another notch! If the ring nut is still quite tight, you may need to cut a second notch to keep the ring nut turning further until it loosens enough for the strap spanner to remove it. If the ring nut won’t budge at all, some heat may be applied directly to the ring nut (but nowhere else!), immediately followed by the cold chisel and hammer. The peening does not interfere with the threads on the hub body or the ring nut.

A point of interest in Photo 9 is that this particular output shaft drive flange has been fitted with double-ended studs. In theory, this should give a longer life to the drive flange threads because the usual six bolts are not being repeatedly tightened into the drive flange, so should a thread ever be damaged, it is a simple job to replace a stud while extending the life of the drive flange. (Photo 9 courtesy of Peter Fosselius).

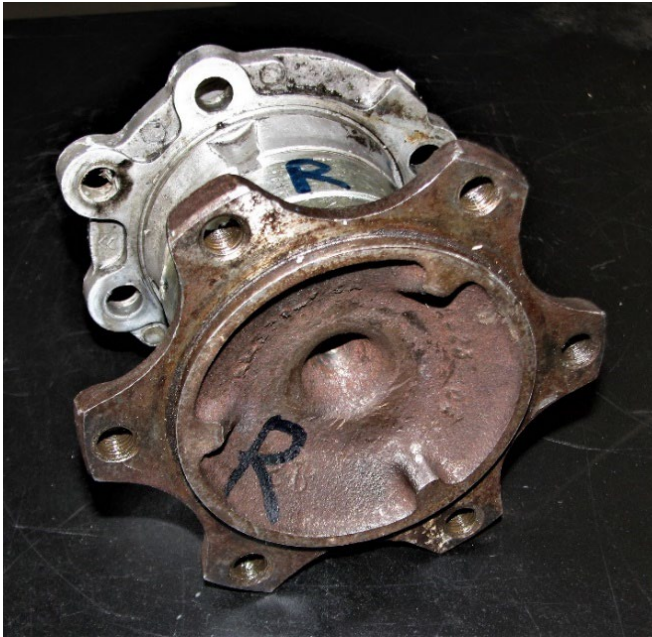
Photo 12: Ah, found it! Another view of the output hub, showing the third “R” on the drive flange of the output hub shaft.

To repeat, keep the three items marked with an “R” and the steel shims as a matched set, in this case, for the right side. Do the same for the left-side items. This is vital.

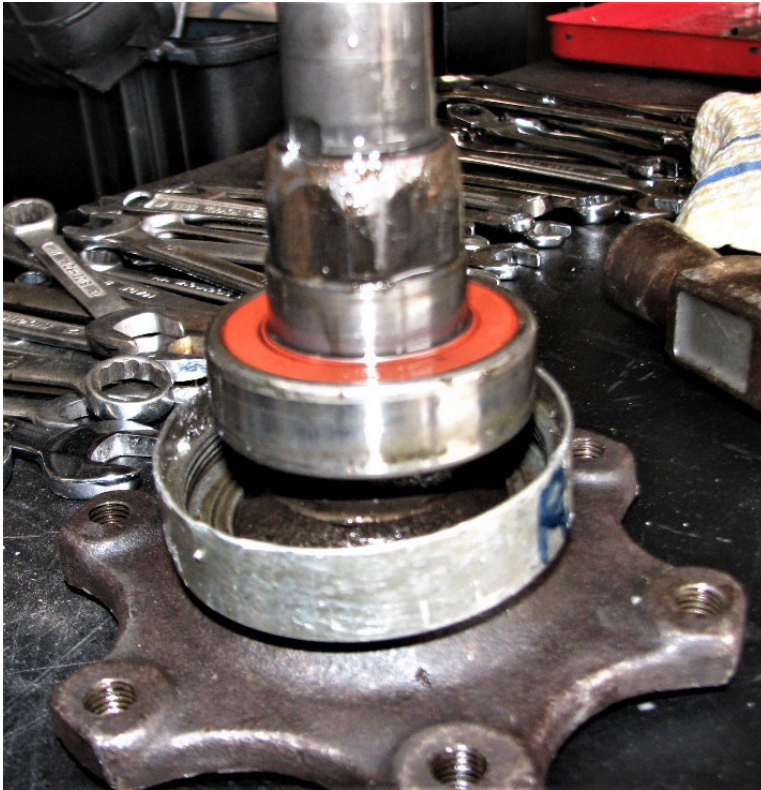
Photo 17: The output hub shaft assembly after being withdrawn from the hub. Shows the shaft, the lock nut, the steel spacer, the sealed bearing, the unscrewed ring nut and the output shaft drive flange.

The bearing, which is pressed onto the shaft, is size **25x52x15 mm** and is a lifetime sealed type.

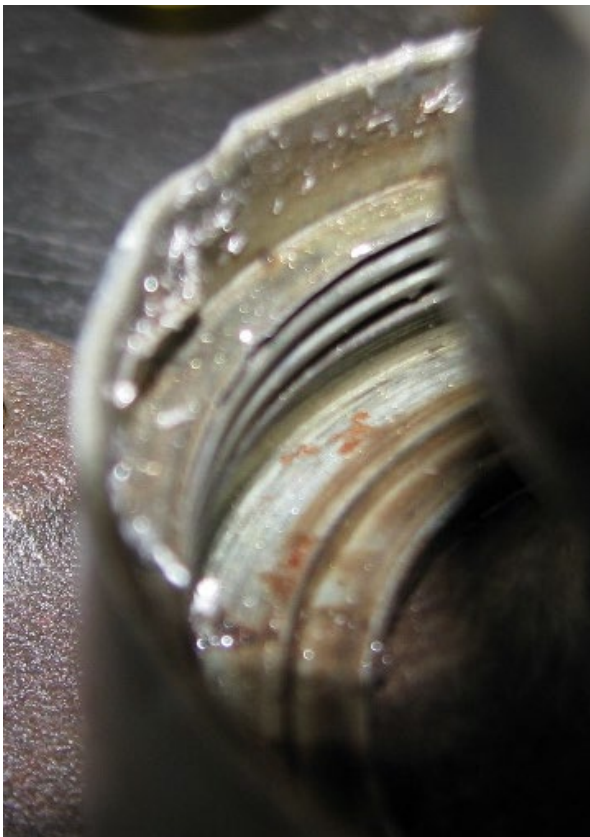
Photo 18: A close-up of the inside threads in the ring nut.

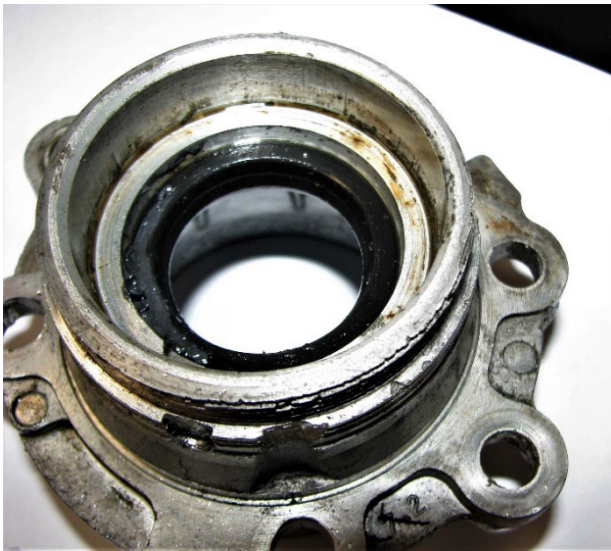
Photo 19: Shows the output hub oil seal of size 31x42x8 mm. Fitted from the outer end of the hub (upper-most opening in the photo). The open side of the seal (with the rubber lip and spring) faces downwards in the photo, i.e. **towards** the gearbox.

Remove the old oil seal and clean the hub thoroughly. Apply rubber grease to **all** metal surfaces of the hub which will come into contact with the new oil seal.

Apply rubber grease to all surfaces of the new oil seal and fit the seal into position in the hub.

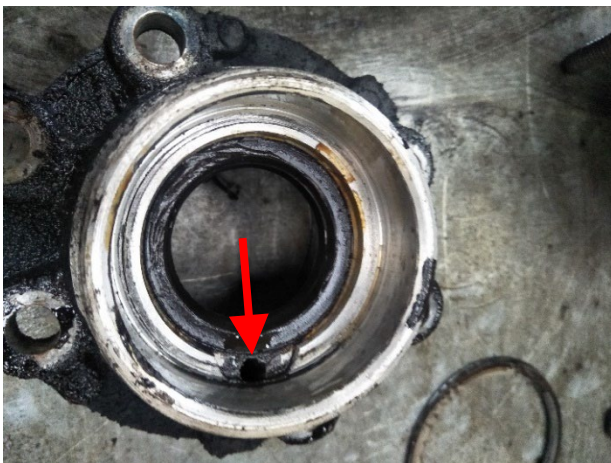
Photo 21 above left shows the oil drain hole located at the **bottom** of the hub bearing housing.

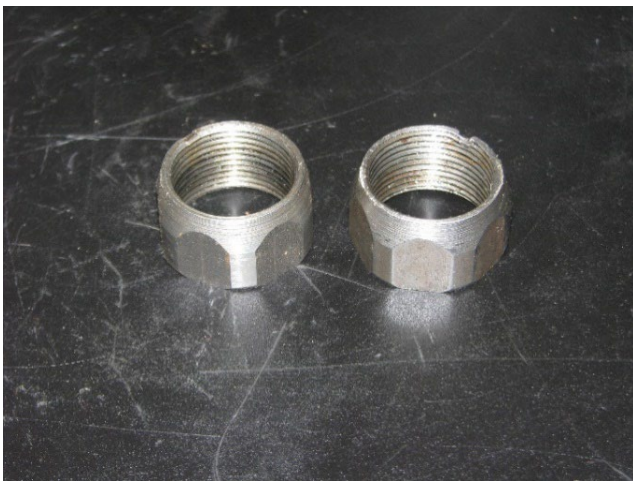
Photo 24: The lock nuts on the output hub shafts. These are tightened to **75 foot-pounds**. Add some copper grease first. The upper edge of each nut is peened into the opening in the shaft before the hub is finally reassembled and returned to the vehicle. The previous peening points are shown on the nuts. Ensure everything is spotlessly clean.

If the lock nuts need to be removed, swap them over between the two hubs so the peening points will (very likely) be in different positions on the nuts.
