2CV HARD LUCK STORIES

Revision 5

Graeme Dennes

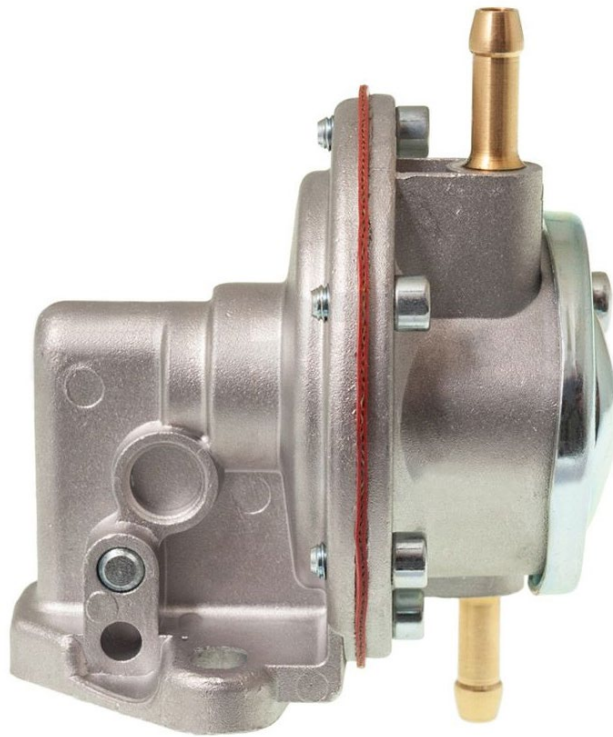
2CV Fuel Pump

While away from home, our orange 2CV would run for perhaps 2-3 km, then almost die from what seemed like fuel starvation, but, with much encouragement it would (blorp, blorp, blorp, just) come good again, and after a couple of kangaroo hops, off we'd go again (blorp, blorping blorping), with the process being repeated. Fuel was not overflowing from the carburettor, which would otherwise indicate a failed float valve. It seemed probable that it was being caused by either dirty fuel (possible), a restriction in the fuel line from rubbish from the tank (less likely), a dirty fuel filter (possible, but the filter had just been changed), a sticking carburettor float valve (repeated cycling with a sticking action is very unlikely), dirt in or around the carburettor jets (possible), or a fuel pump failure (possible). It could also have been due to rubbish trapped in the fuel filter, whereby the very act of fuel being drawn through the fuel filter by the pump pulls on the rubbish sufficiently to cause the filter to block itself off, when the engine would stop or almost stop, at which point the rubbish would fall away again, allowing fuel to pass, and repeating the cycle. However, as the fuel filter had just been replaced as noted, I discounted that option for the moment. I therefore put my money on the fuel pump diaphragm, so my first step was to disconnect the rubber fuel hose from the carburettor fuel inlet spigot, then start the engine for just a few seconds to check how much fuel was being discharged from the fuel hose. Ah ha, gotcha! It was found to be almost zero. As no spare fuel pump or diaphragm was carried as a spare, RACV Total Care gave us a lift home!

I later confirmed that the fuel pump diaphragm had suffered a small tear, causing the problem. The diaphragm material had also become sufficiently "floppy" such that very little pumping action was occurring anyway.

And what have we learnt? As the fuel pump diaphragm is not generally inspected, my new rule is to change it every five years, reminding myself by an entry in the maintenance log book. If unsure when the diaphragm was last replaced in your car, do it now as a matter of urgency. Always carry a new spare diaphragm or pump with you.
