2CV IGNITION COIL

Revision 10

Graeme Dennes

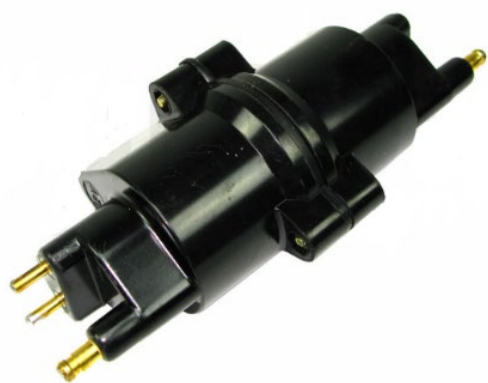
The photo at left shows the standard black 2CV ignition coil. Traditionally, points-ignition coils are designed so that a voltage of around 300V is induced in the primary winding by the collapsing magnetic field. In the 2CV coil, by reverse engineering, the collapsing field induces 300V in the 200-turn primary winding, so a basic coil design constant is 1.5V per turn. The 15,000-turn secondary winding receives, *at the exact same moment*, an induced voltage of $1.5\text{V} \times 15,000$ or 22,500V from the shared, collapsing magnetic field in the iron core.
