2CV BATTERY PROBLEMS SOLVED

Revision 9

By Graeme Dennes

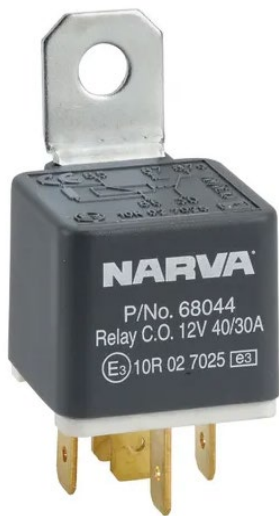
The Bosch RE57 regulator and Narva relay and socket are usually available at auto parts stores, and often appear on eBay. Do an ebay search on "RE57". Don't use substitute products for the voltage regulator, the relay or the socket. Below is a photo of the relay.

Four wires connect to the relay socket via brass spade connectors and these are pressed into and locked in the bottom of the relay socket after being crimped to the wires. Identify the correct orientation for the brass spade connectors *before* inserting them into the relay socket. These connectors are usually supplied with the socket. Three red-coloured crimp connectors are needed for connecting to the RE57 voltage regulator pins. Two crimped connectors of a size suitable for mounting under the battery post bolts are also needed to connect the regulator D- terminal to the battery negative post and to connect pin 30 of the relay socket to the battery positive post. Ensure all crimps are correctly fitted to the wires using correctly sized and adjusted crimping tools.
