2CV BATTERY PROBLEMS SOLVED

By Graeme Dennes

Revision 3

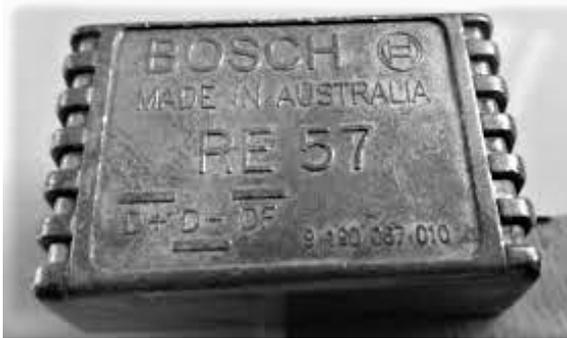
On the left is a photo of the Bosch RE57 voltage regulator, packaged in a small metal die-cast case. It's a sealed, non-adjustable three-terminal (D+, DF, D-) device which provides an install-and-forget solution. It has a voltage set point of 14.2V. More follows. The regulator's metal case is a heatsink, so mount the unit firmly on the firewall.

Note: A similar voltage regulator is the Bosch RE55 which is a two-terminal device. It uses the metal case of the regulator as the negative terminal. You don't want this regulator. You want the three-terminal RE57 regulator with the separate ground pin which can be wired *directly to the battery negative post* to achieve an electrically "stronger" (more direct) connection. If someone tries to convince you the RE55 will do the same job as the RE57, they definitely don't understand the intricacies of voltage regulation and the effects of wiring resistances on the charging of the battery!

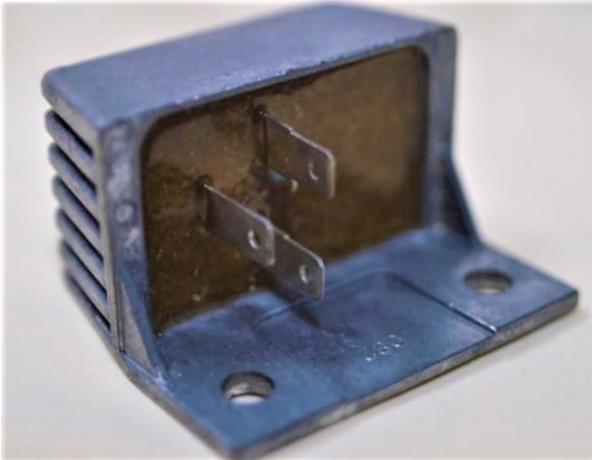
The photo at left shows the underside view of the Bosch RE57 regulator with its three connection pins. Note: Almost hidden behind the top pin is the end of a resistor projecting above the epoxy fill. If the exposed resistor wire is cut, the regulator's voltage set point is changed from the default of 14.2V to a modified 15.2V to compensate for diode-isolated charging situations such as in dual battery setups, where voltage drops occur across the diodes.

For single battery installations ala 2CV, use the default voltage set point of 14.2V, ie, **don't** cut the resistor wire!

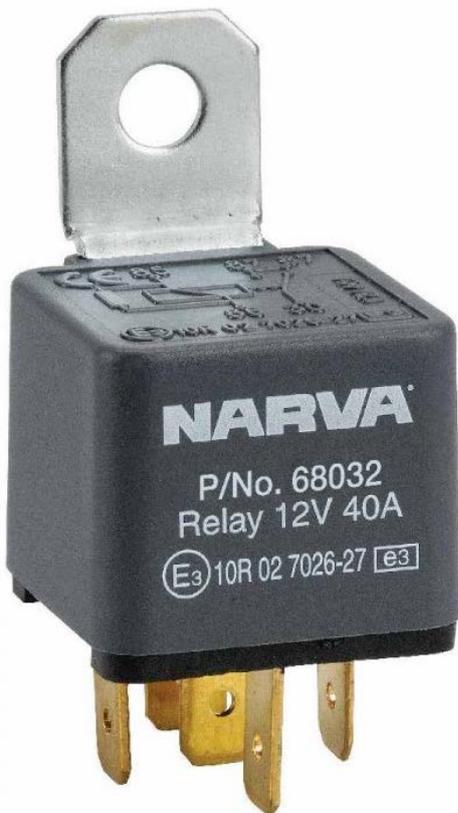
The Bosch RE57 regulator and Narva relay and socket are usually available at Autobarn, and often appear on eBay. Don't use substitute products for the voltage regulator, the relay or the socket. Below is a photo of the relay.

Four wires connect to the relay socket via brass spade connectors and these are pressed into and locked in the bottom of the relay socket after being crimped to the wires. Identify the correct orientation for the brass spade connectors *before* inserting them into the relay socket. These connectors are usually supplied with the socket. Three red-coloured crimp connectors are needed for connecting to the RE57 voltage regulator pins. Two crimped connectors of a size suitable for mounting under the battery post bolts are needed to connect the regulator D- terminal to the battery negative post and to connect pin 30 of the relay socket to the battery positive post. Ensure all crimps are correctly fitted to the wires using correctly sized and adjusted crimping tools.

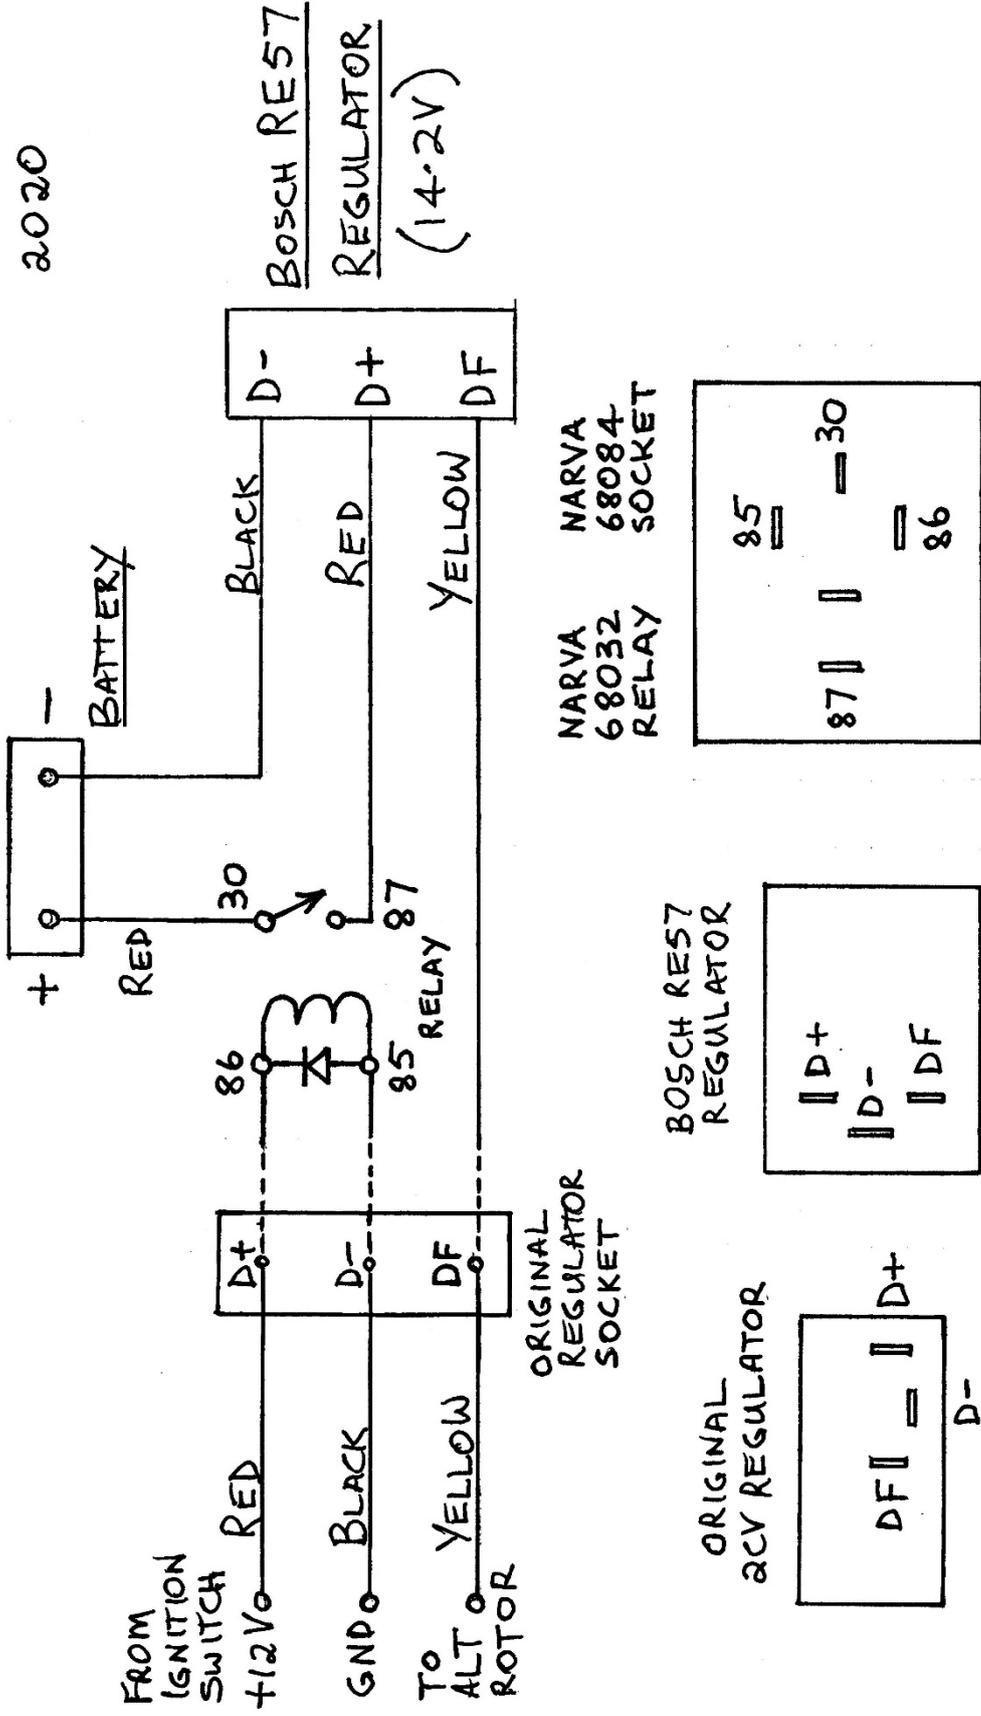
2CV REGULATOR-RELAY WIRING

The attached circuit diagram shows the modified wiring needed to connect the RE57 voltage regulator and relay to your 2CV to replace the original electro-mechanical voltage regulator. Briefly, when the ignition switch is turned on, the original D+ (12V) connection from the ignition switch is used to activate the relay. When the relay is activated, its closed contacts connect the D+ terminal of the RE57 regulator to the battery positive post. So now, with the RE57 regulator's D+ and D- terminals connected *directly* to the battery posts, the RE57 can finally sense the *true* battery voltage and ensure the battery is properly charged and kept properly charged, our *raison d'être*!

At the lower section of the circuit diagram is shown the pin layout diagrams and pin designators for the original 2CV regulator, the RE57 regulator and the Narva 68032 relay and 68084 socket **when looking directly at the connection pins, as is noted**. (This is the industry standard for viewing device pins). As may be seen in the photo above, the pinout for the RE57 regulator is also provided on the top face of the regulator, just below the "RE57" designator. After attaching the small metal mounting bracket supplied with the relay to the relay cover, mount the RE57 regulator and the relay and socket next to each other on the firewall, close to the battery, with their connection pins pointing downwards. Three short wires with spade crimp terminals can be made up to extend the three connections (D+, D- and DF) from the original regulator socket. Alternatively, the socket could be removed and the wires extended. The D+ and D- wires connect to the relay coil while the DF wire connects to the DF terminal on the regulator.

THE PIN DESIGNATORS SHOWN ABOVE ARE WHEN LOOKING DIRECTLY AT THE CONNECTION PINS

As shown on the circuit diagram at the last page, the 2CV voltage regulator has three electrical terminals. These are named D+ (Dynamo+), D- (Dynamo-) and DF (Dynamo Field). Although car alternators have been around for some 60 years, the earlier Dynamo (Generator) terminology has generally remained in the automotive electrical industry.

The D+, D- and DF wires terminate at a three-pin socket (shown on the circuit diagram) which connects to the three pins on the bottom face of the standard voltage regulator. This forms the 2CV voltage regulator wiring and battery charging arrangement.

With Revision 3, the relay was changed to a Narva 68032 which includes the integral protective diode across the coil winding shown on the circuit diagram. This relay requires coil wire pin 85 to connect to ground and coil wire pin 86 to connect to +12V at the ignition switch.

Alternatively, to prevent the high voltage spikes from the relay coil being injected into the ignition switch and the switched devices, you'll need to replace the Narva 68044 relay with a Narva 68032 relay (an easy unplug and replace step), then reverse the two wiring connections to the relay coil in accordance with the circuit diagram following.

In summary, if you change the Narva 68044 relay to a Narva 68032, you must also change the relay coil wiring to that shown in the circuit diagram. Thoroughly check your relay coil wiring **before** turning on the ignition switch!
